釜座町町家の由来と町家修復のポイント

History of Kamanza Cho-ie and its Restoration

Kyoto Machiya Revitalization Project

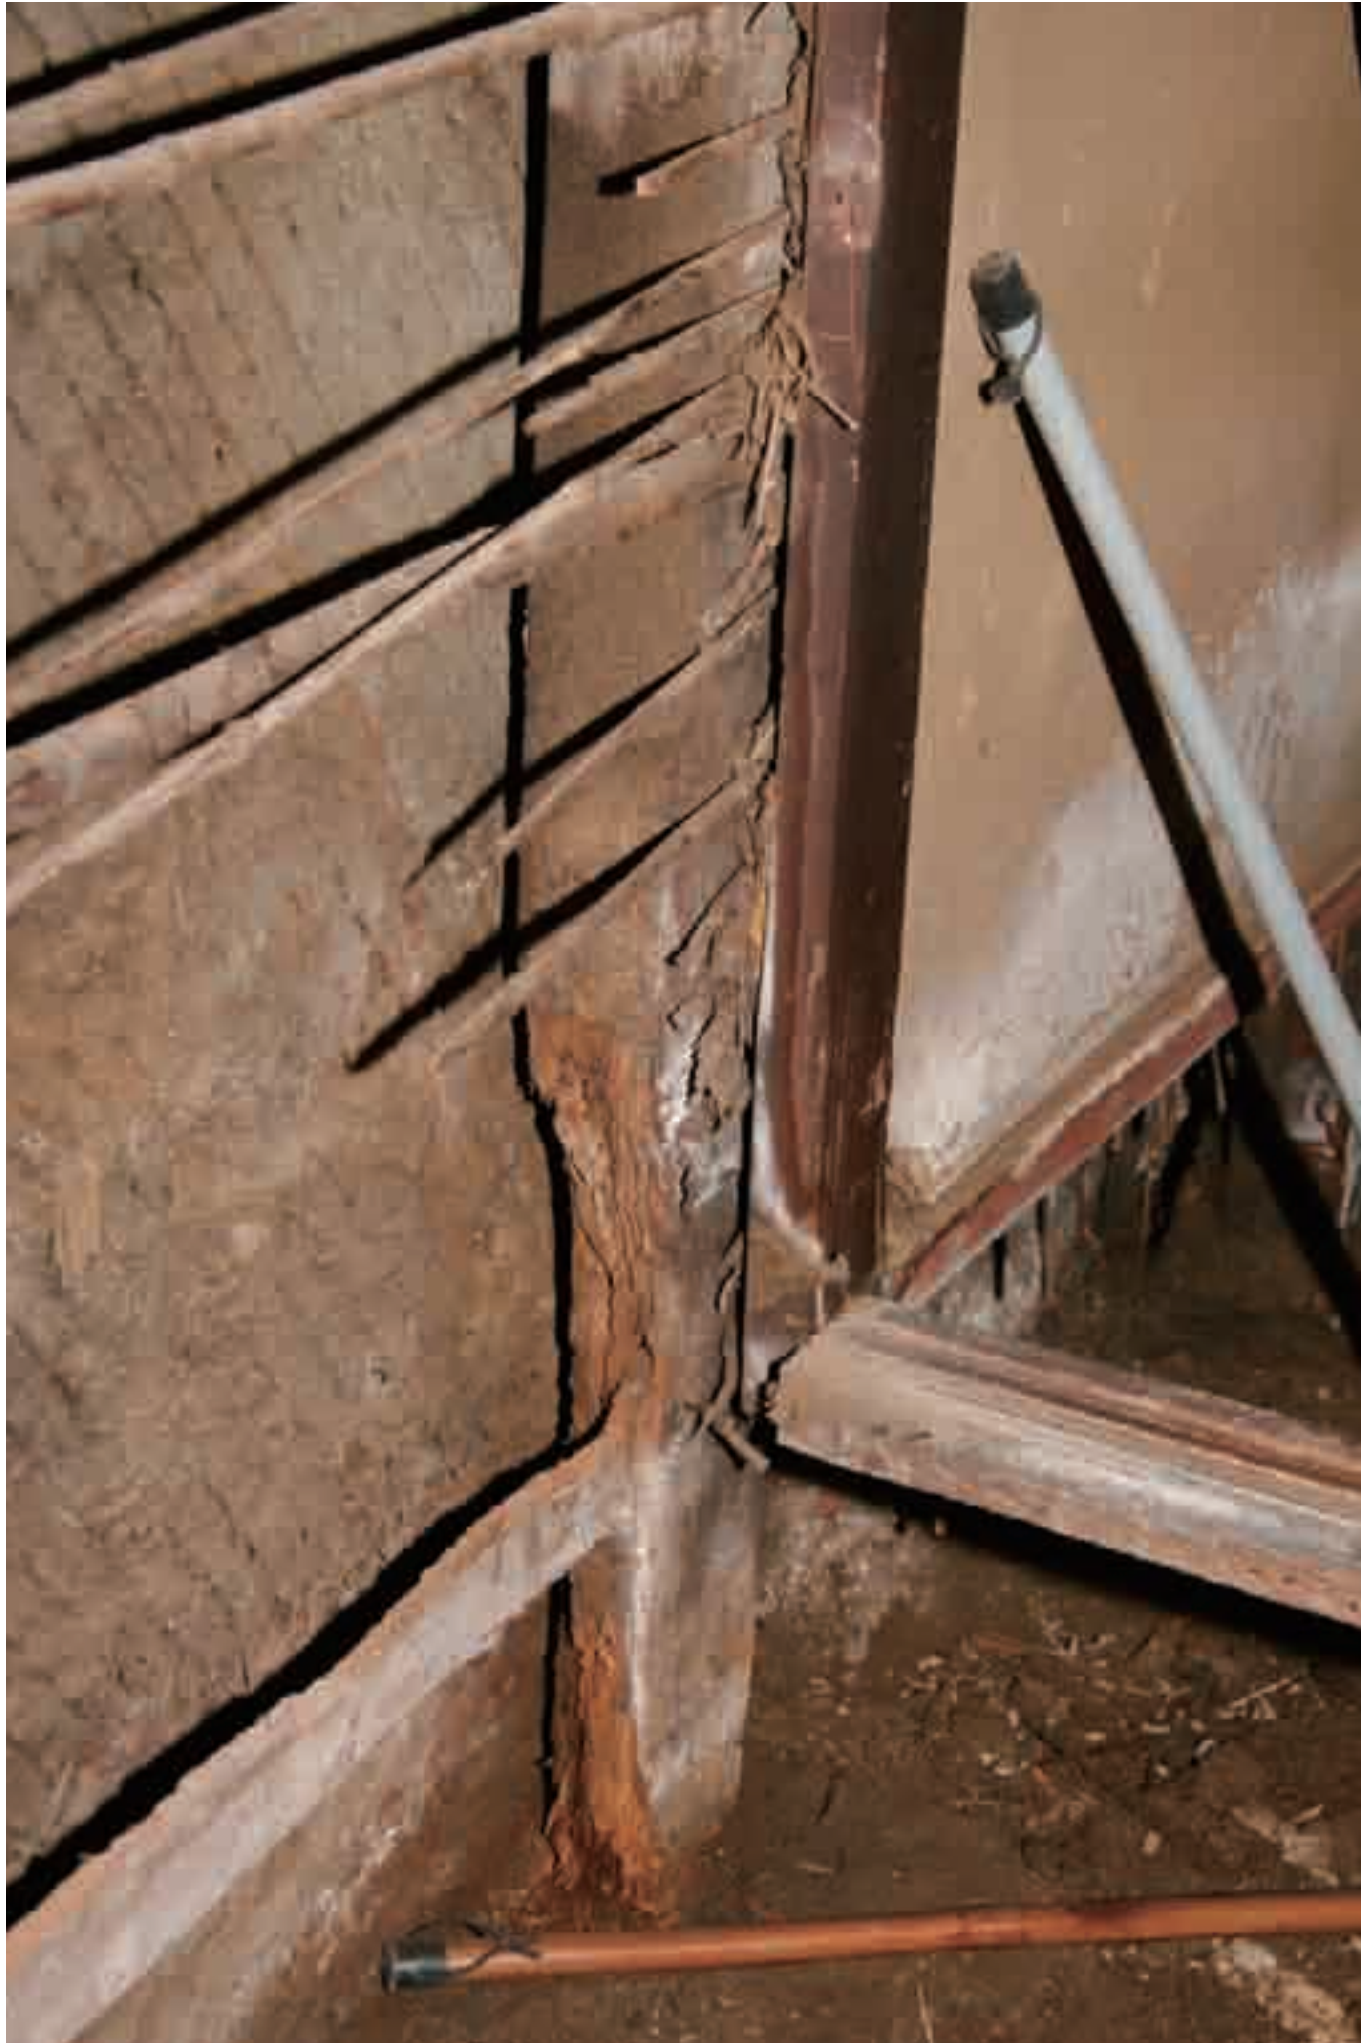
柱の根腐れ rotten post

この症状を記録し、ひとつ石であった基礎石を古花崗岩葛石に差し換え、水平に据え直し、殆どの柱を根^{あひまゑ}継ぎして揚前を行ないました。次に架構全体を^{ゆが}歪み突きして、健康な状態に直した上で土壁を修復しました。2階を10帖に拡大した町家盛時の間取りを保存して、火袋の構造補強を行ないました。

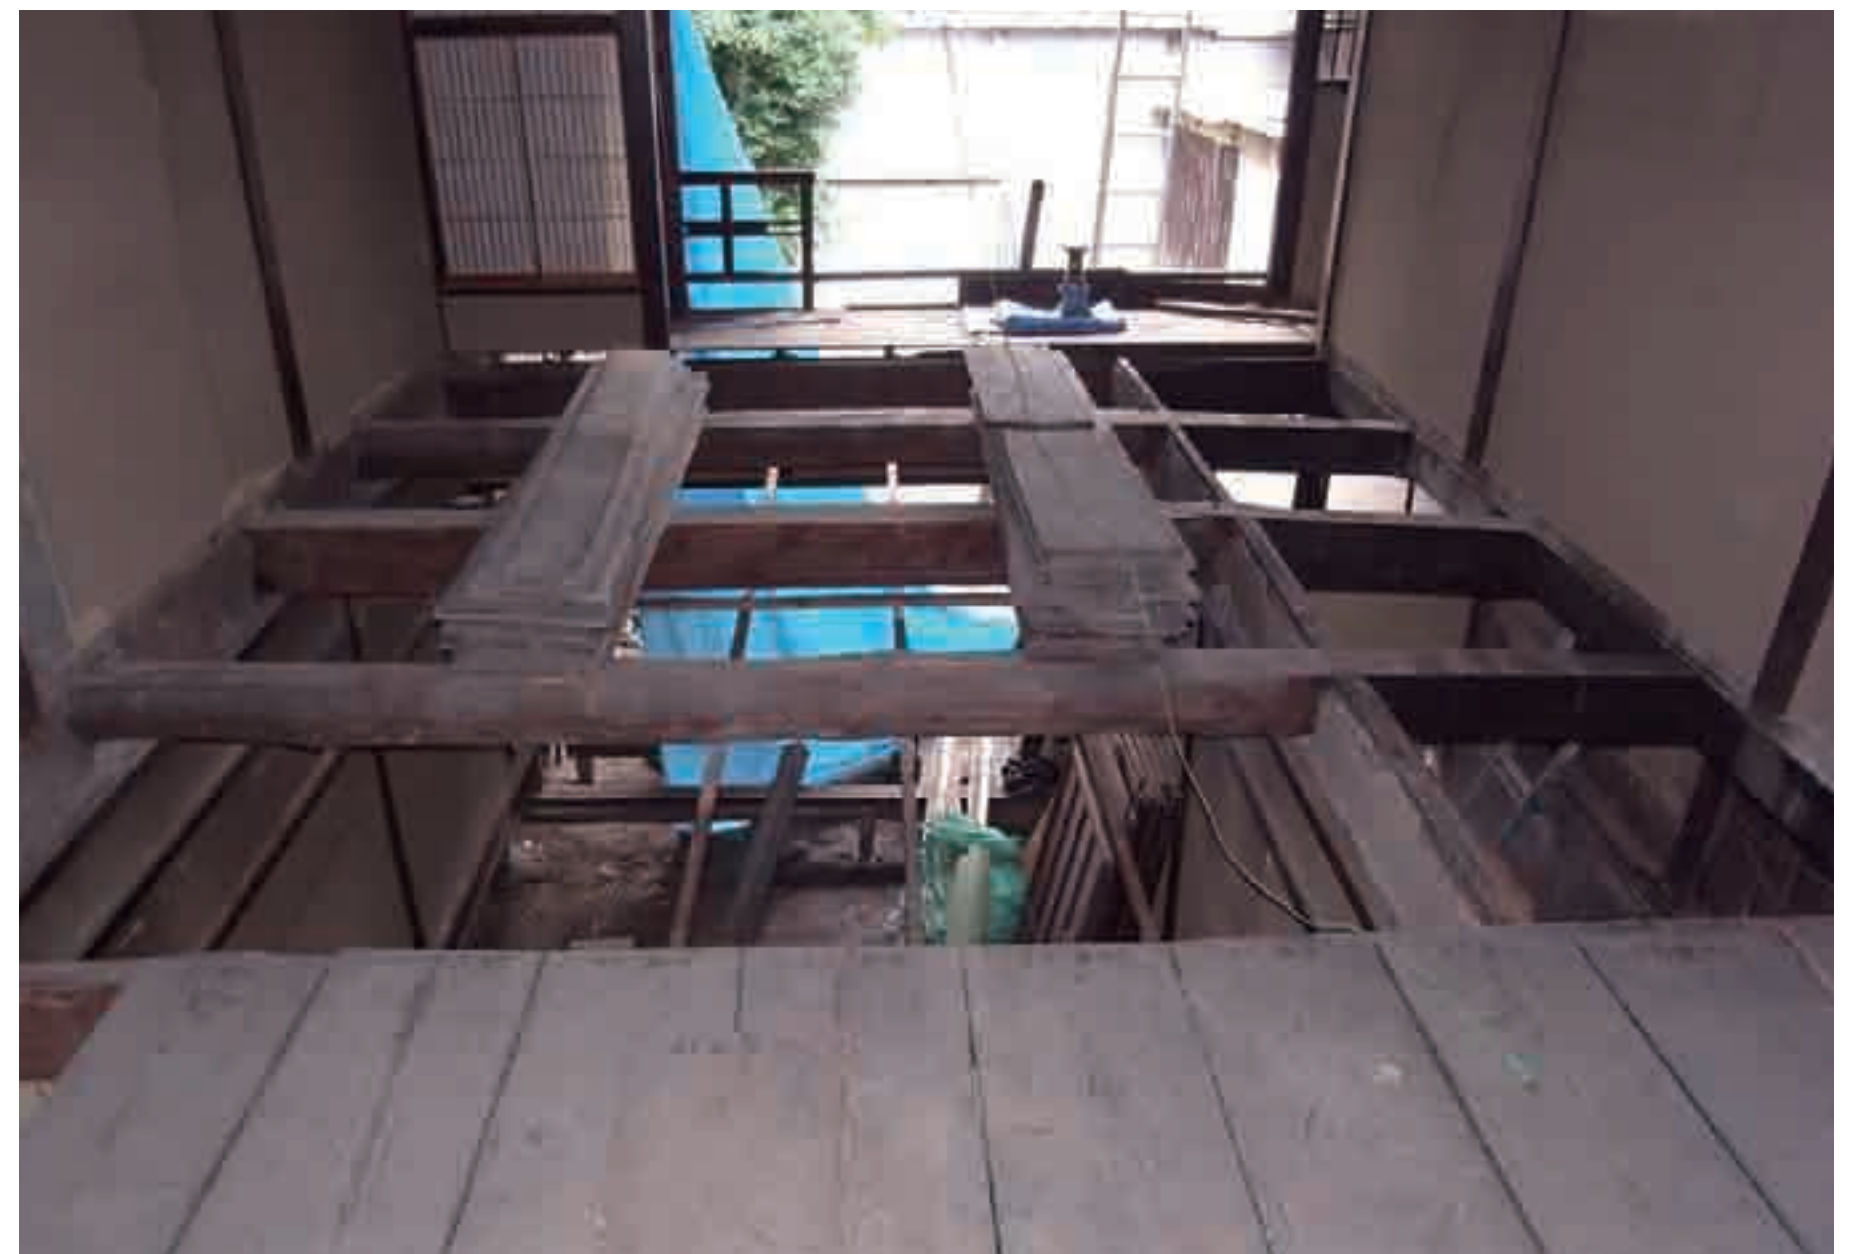
梁の折れ曲がり bent & broken beams

Following this, warped and broken beams were either repaired or replaced and walls re-plastered. The large 10-mat room was left intact and the smoke shaft above the passage way restored.

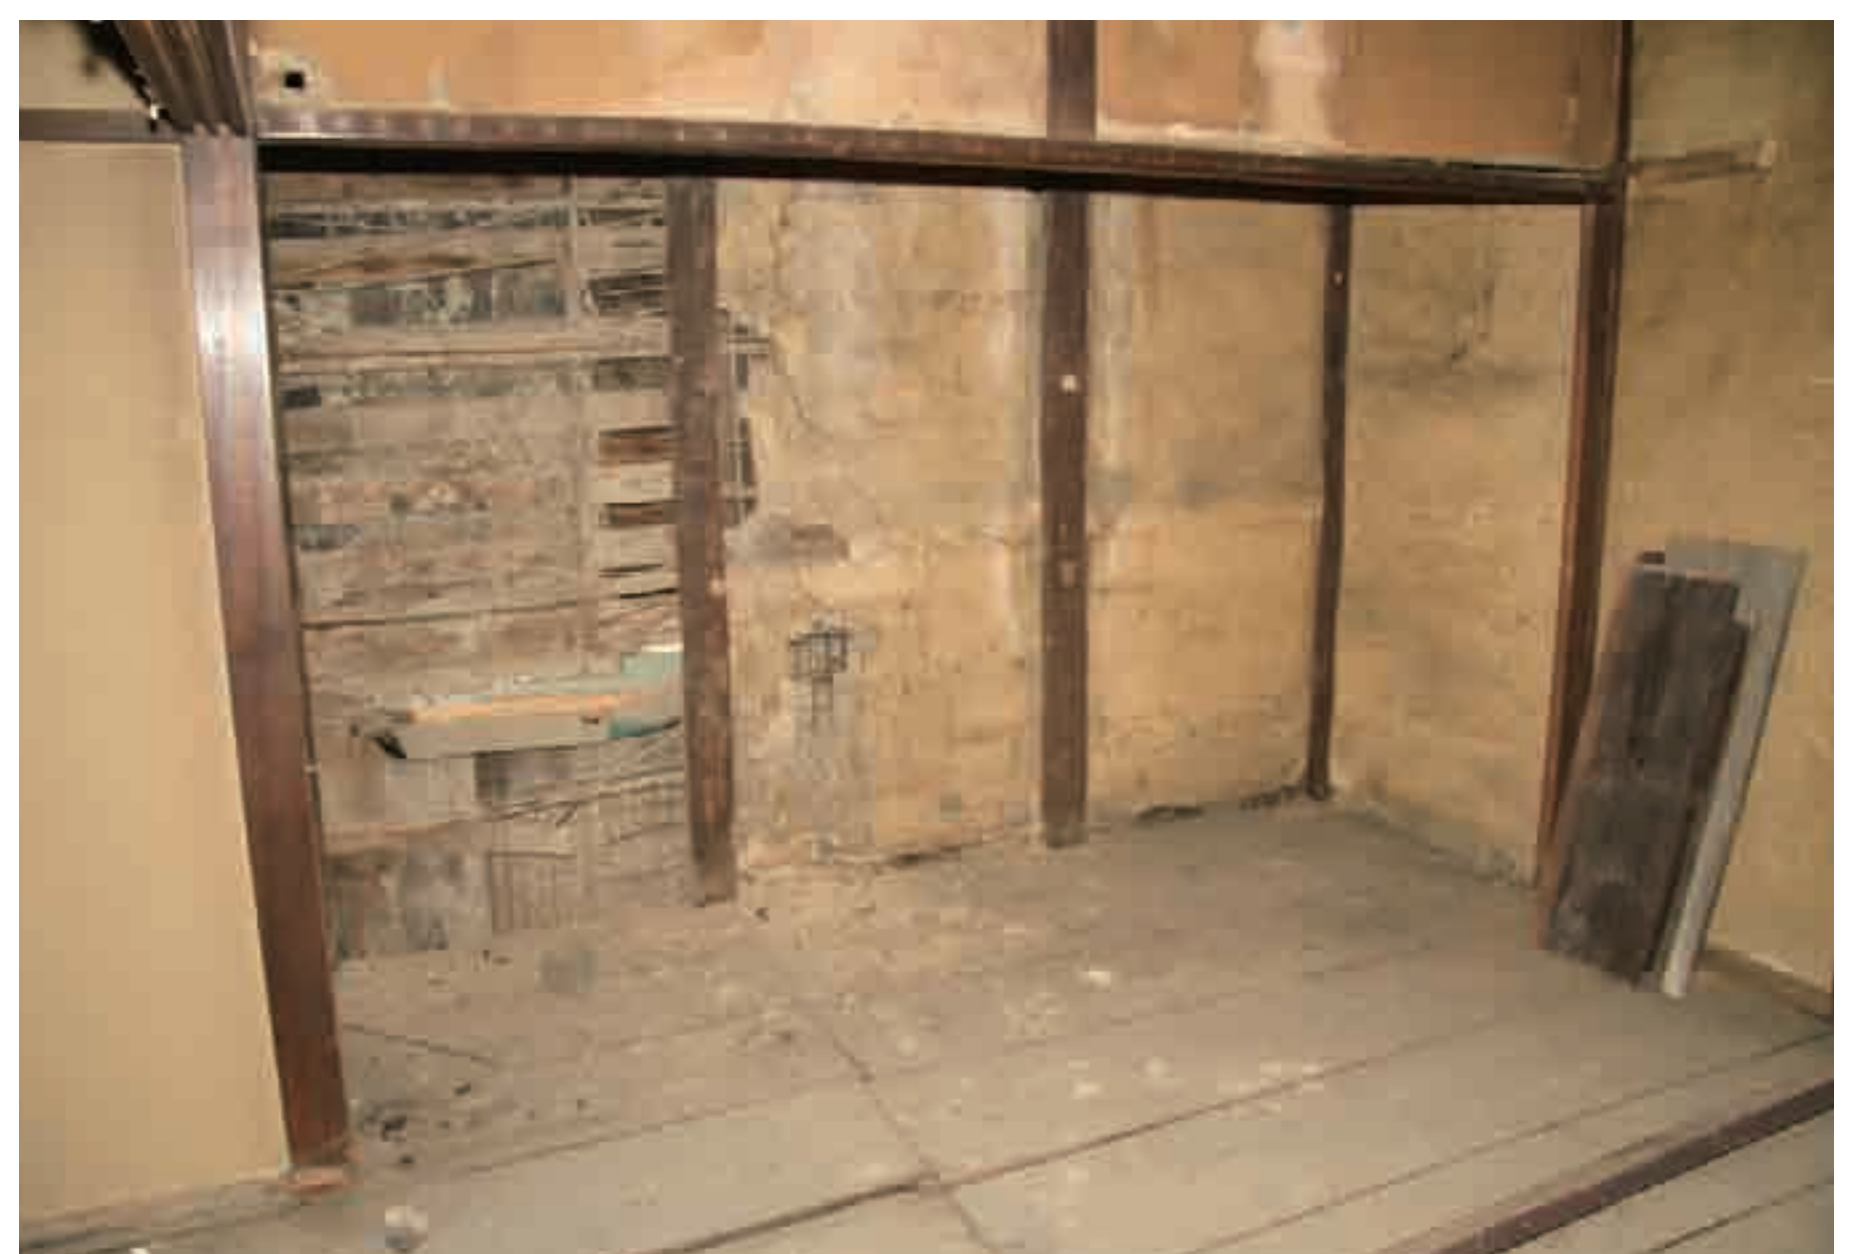
雨水が侵入して壁土が落ちた所 rain-damaged wall

町家改修工事は、近年付加された新建材やクロスをはがして、作事の職方全員が調査をし、建物の復元を構想することから始まります。ここでは後年2階に10帖間を取るために大改造がなされた事や、戦後、奥に3帖間が増築された事が想像されました。更に東隣の敷地が高く、雨水が流入して、トオリニワの側柱が腐って沈下し、骨組全体が大きく東に傾いていました。

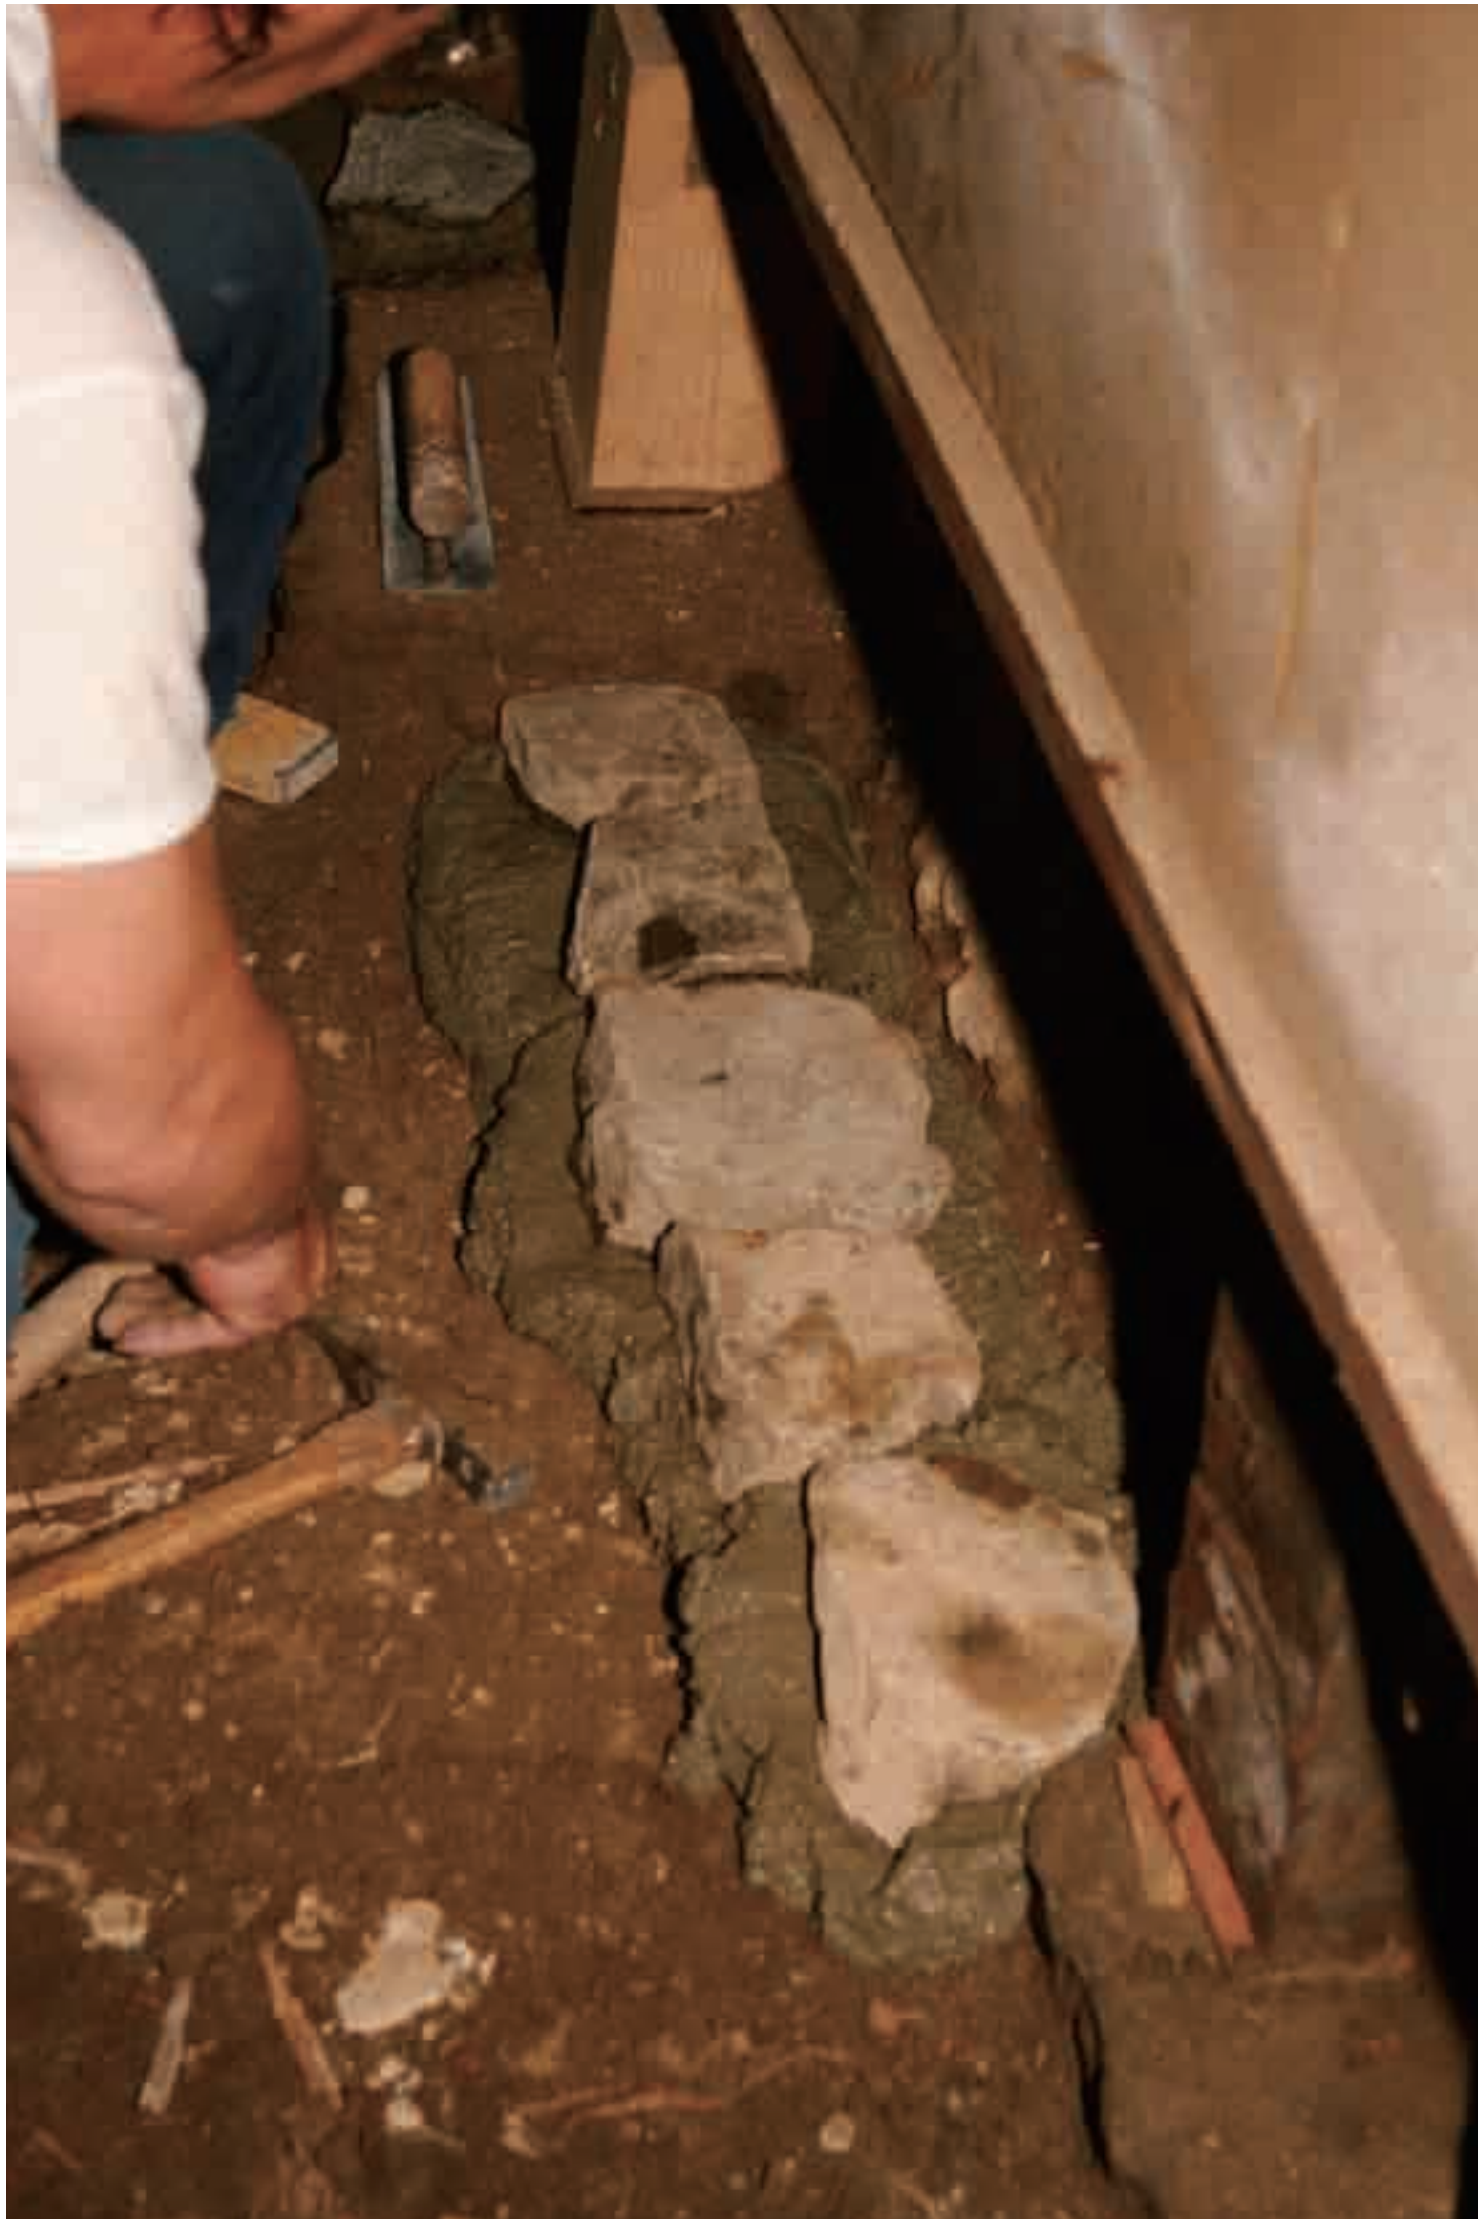
独立礎石を据え直す resetting of individual stones

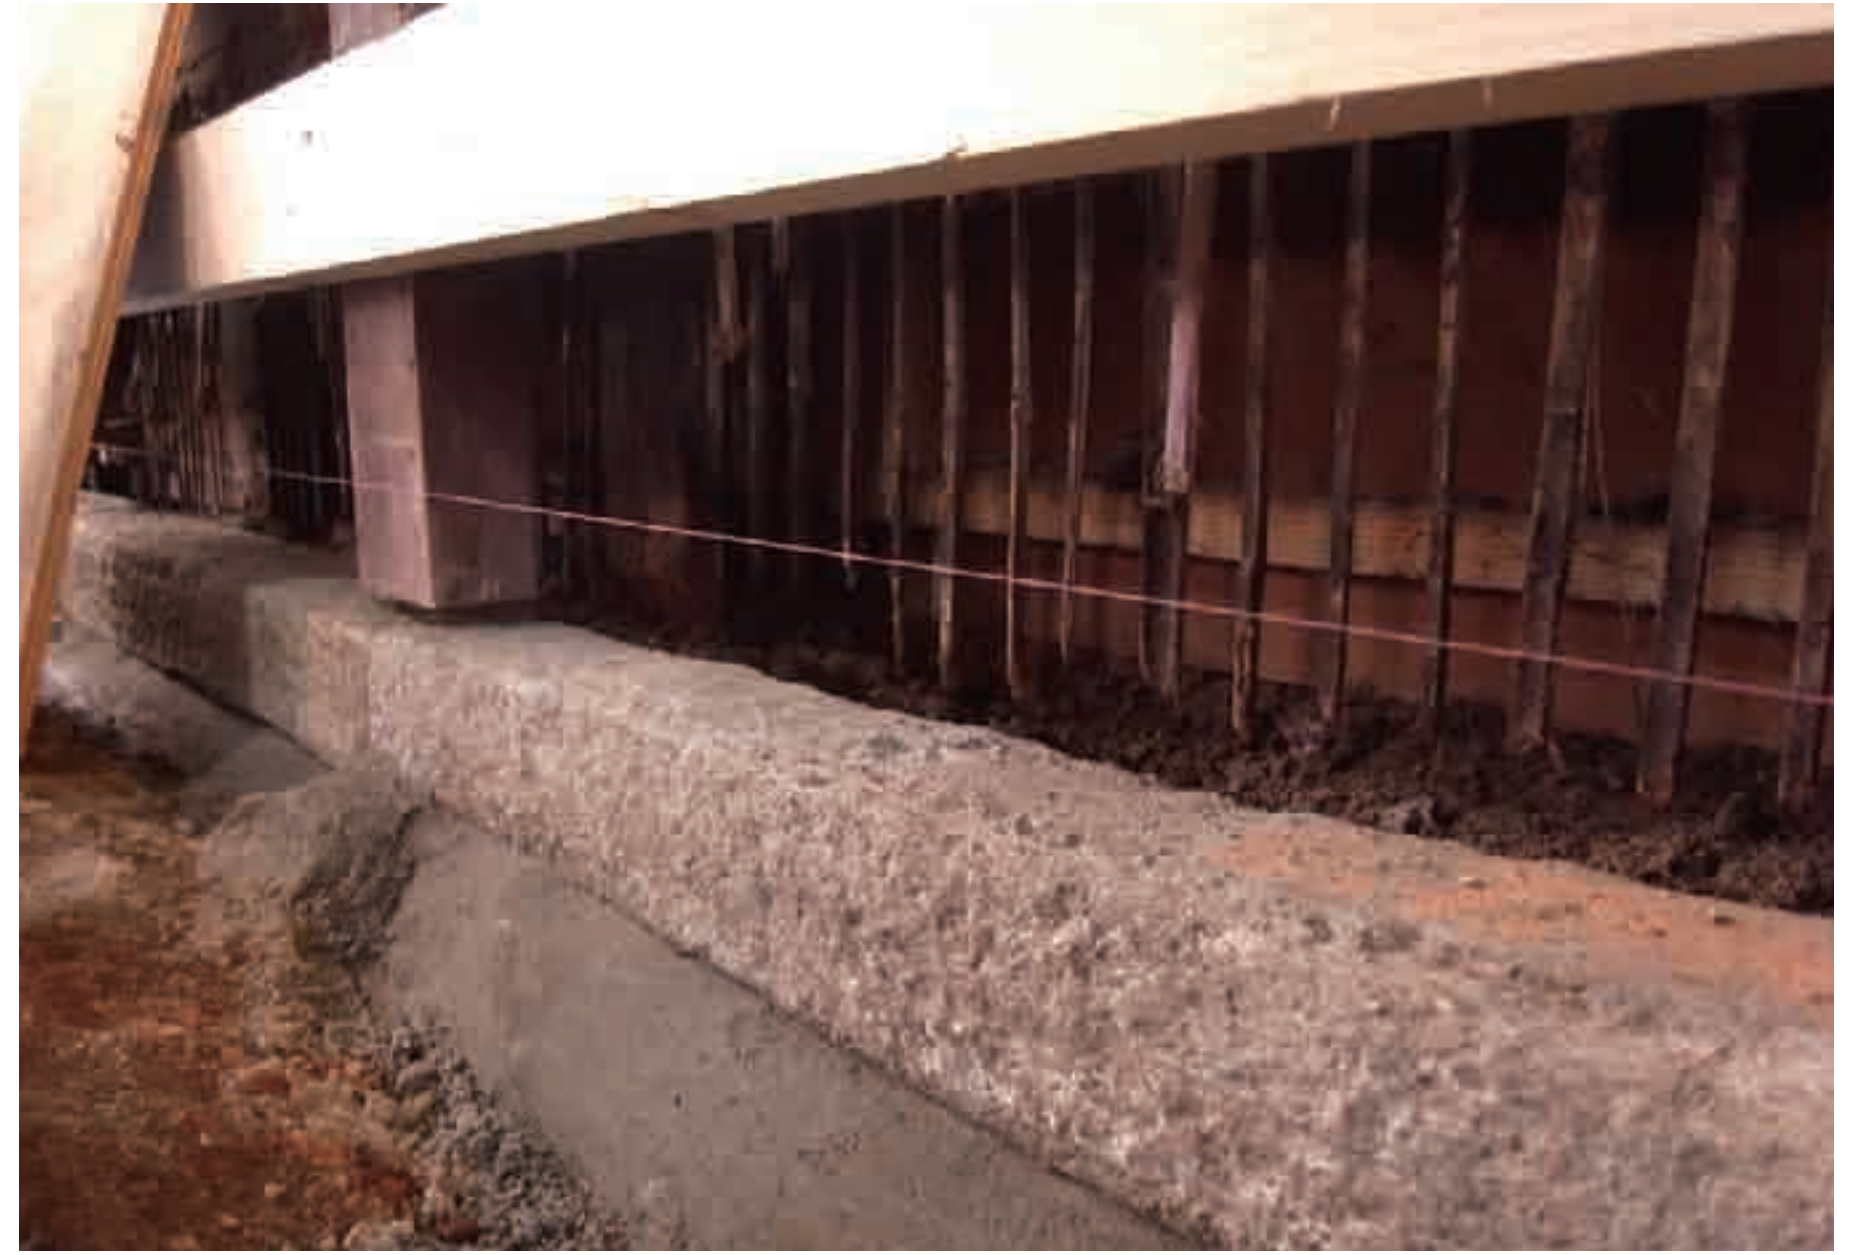
基礎工事 葛石を水平に据え直す leveling foundation stones

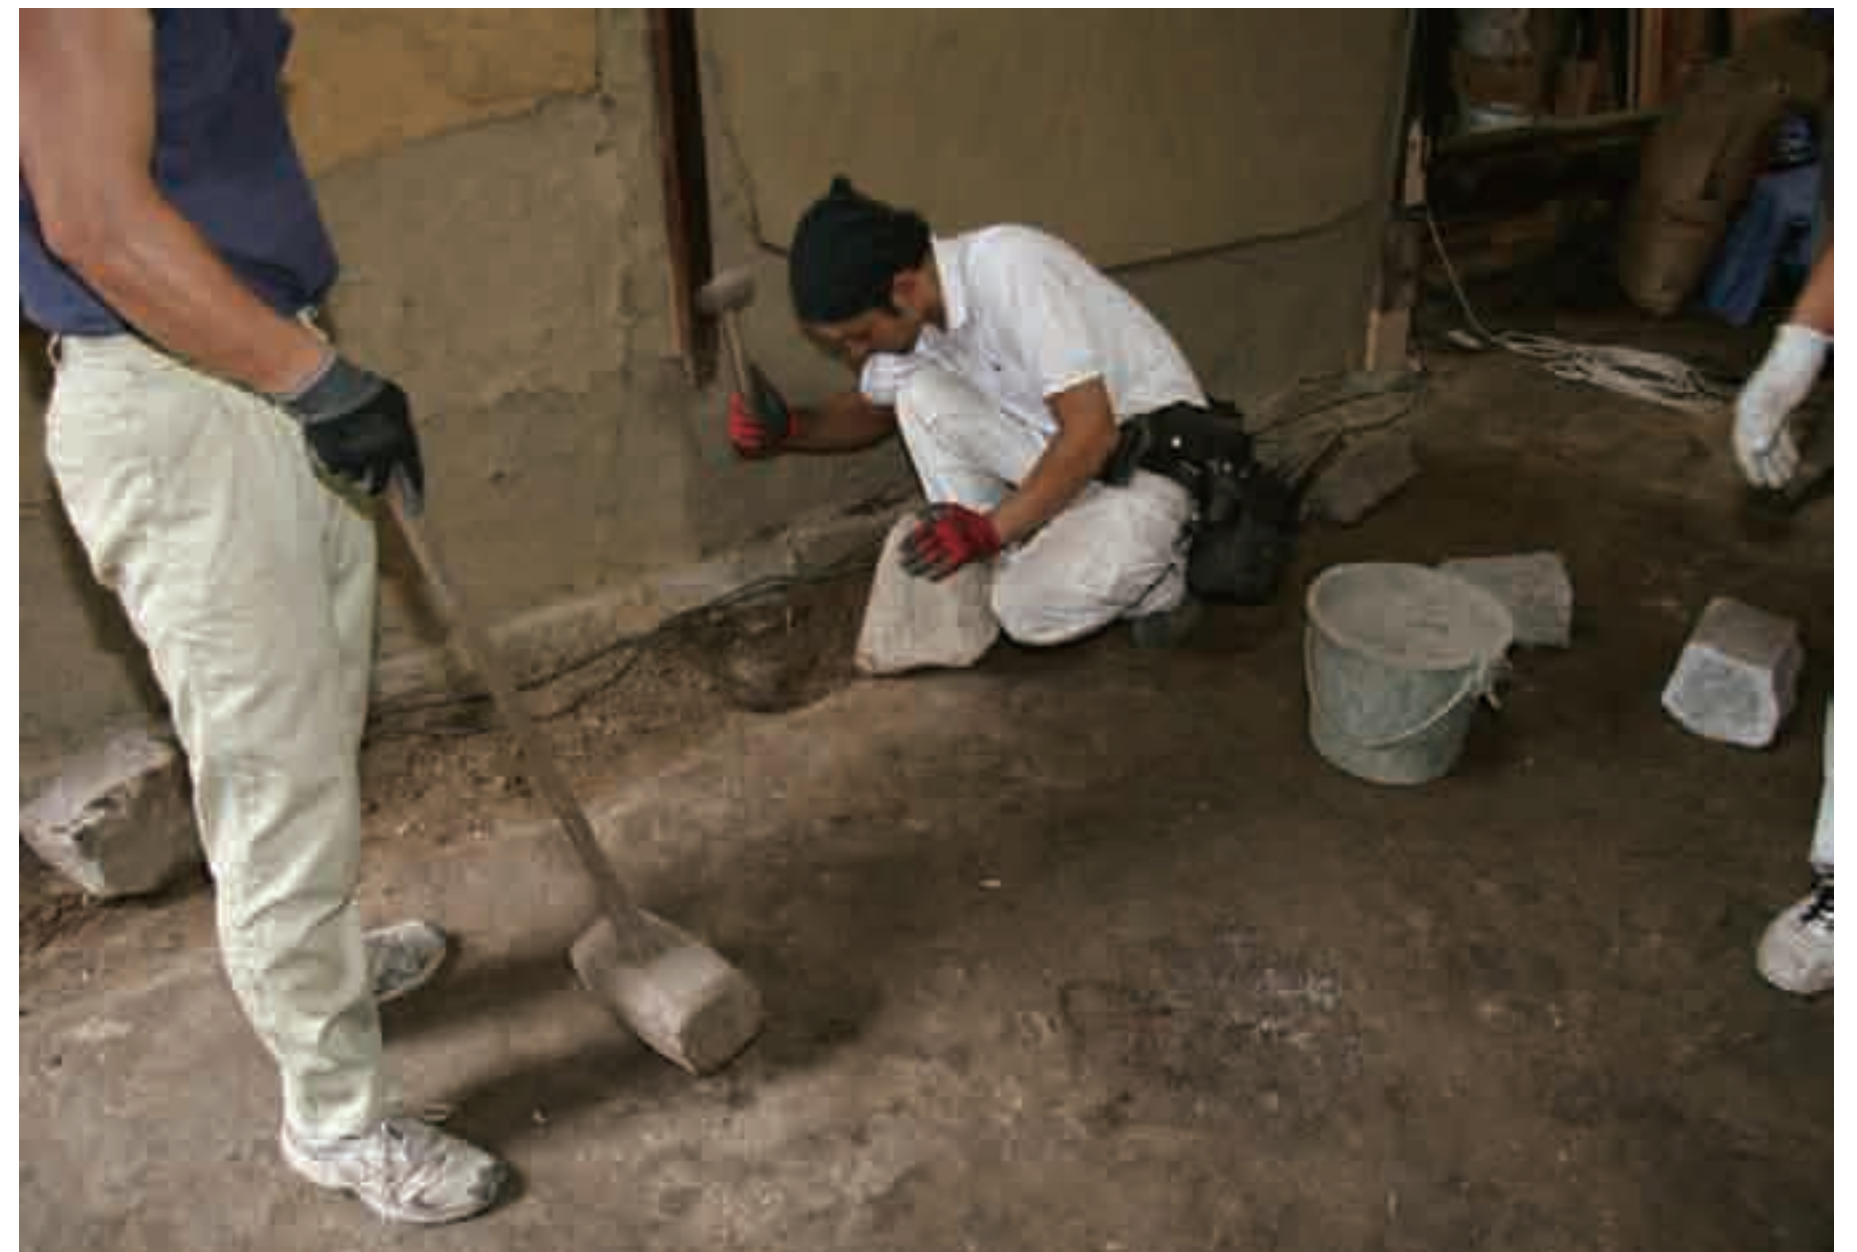
束石を据える setting stones

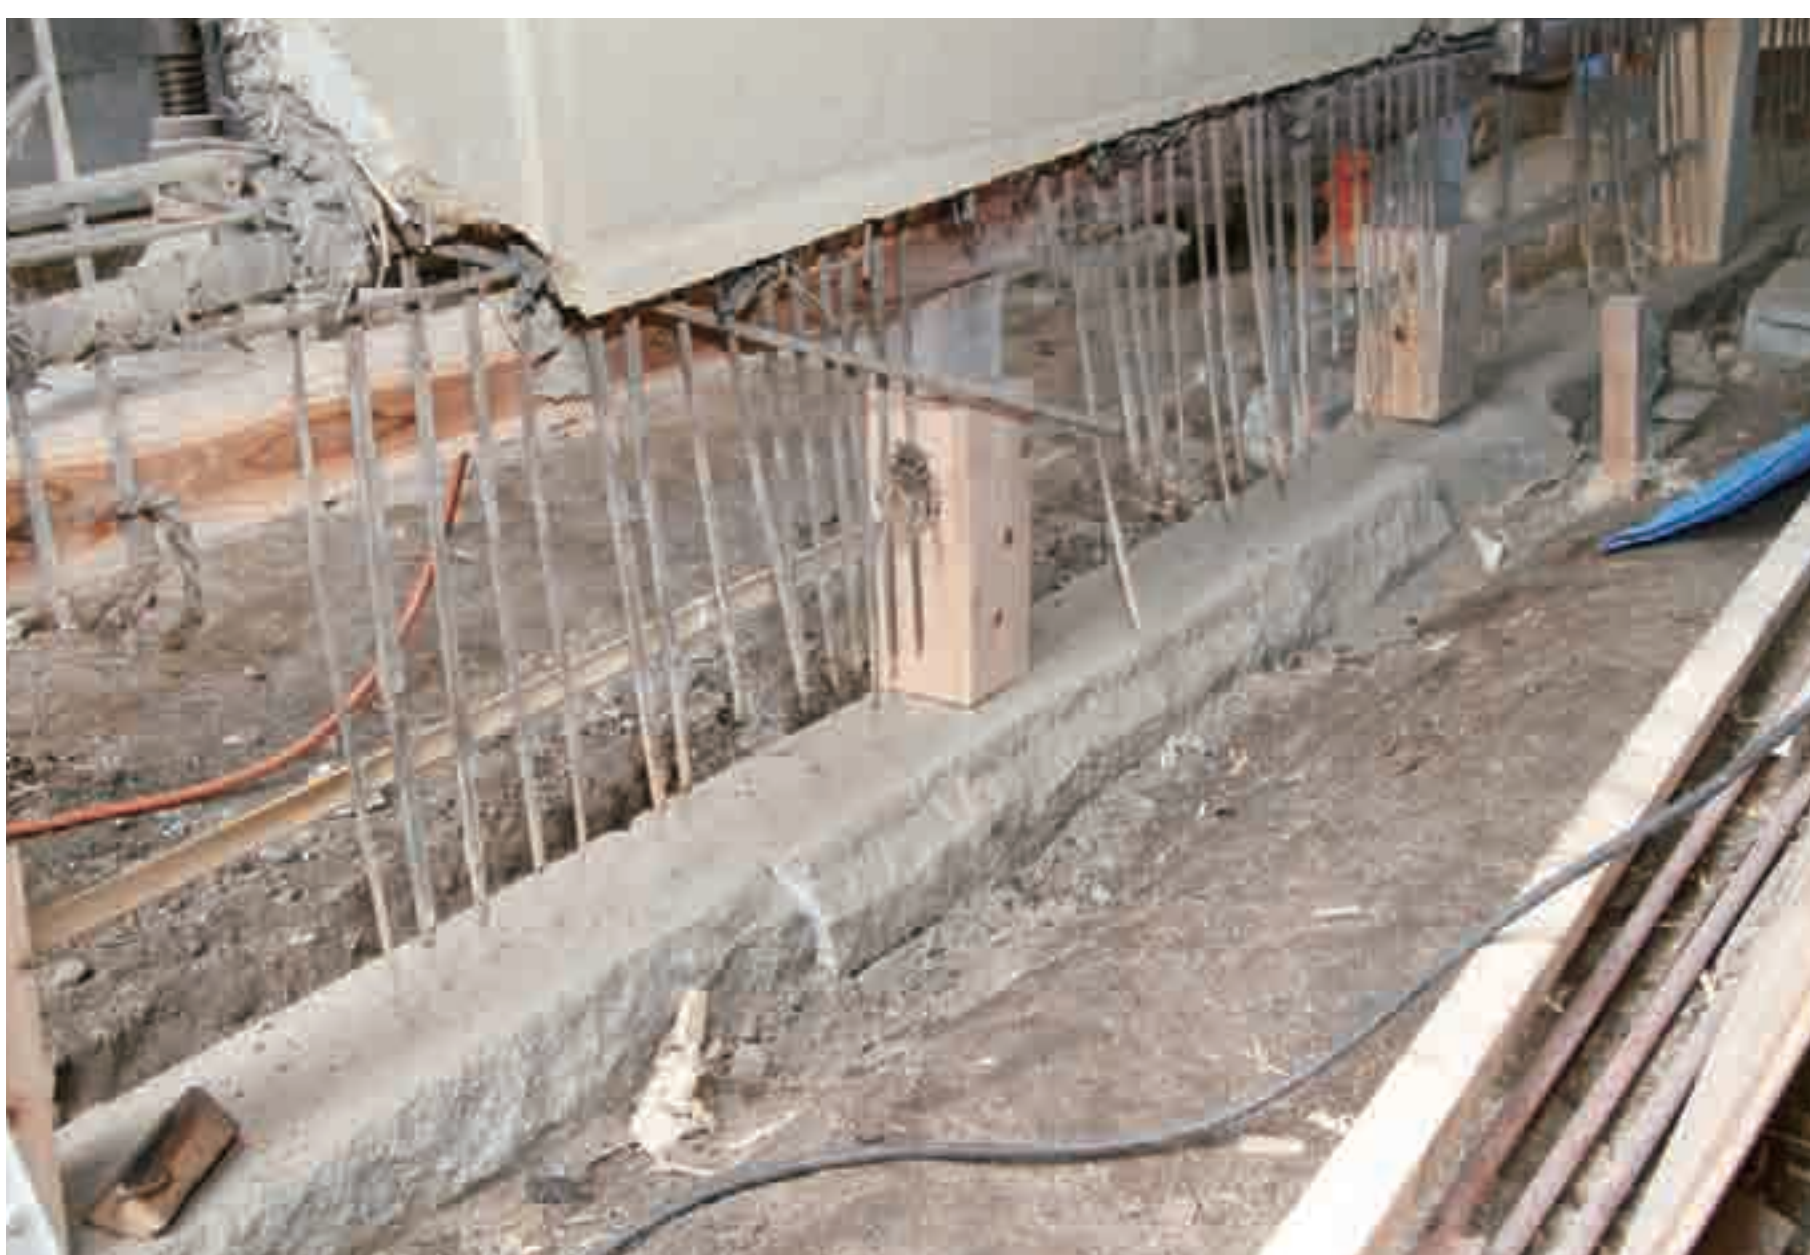
古花崗岩葛石を敷き直し、柱を根継ぎして載せる putting retrofitted posts on long granite stone

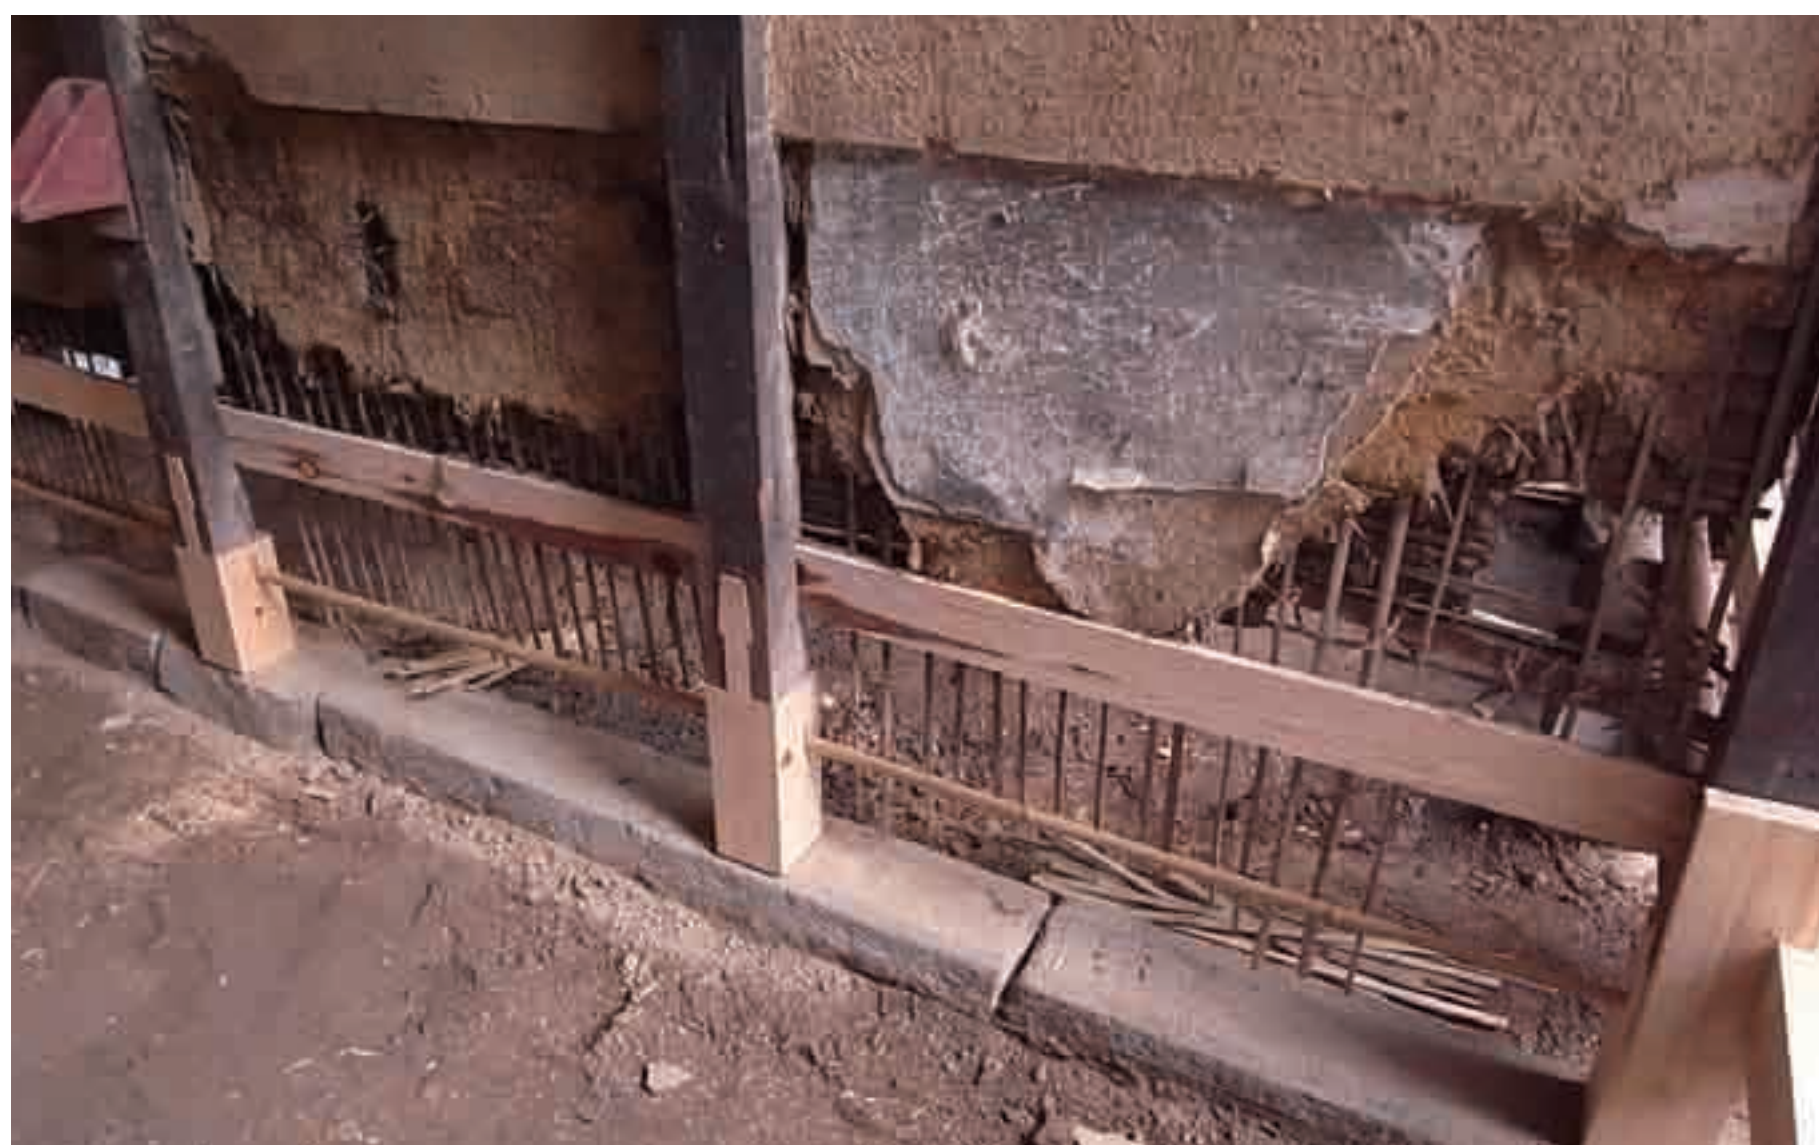
新しく据え直した葛石の上に側柱を根継ぎして載せる（揚前）
adjusting posts level

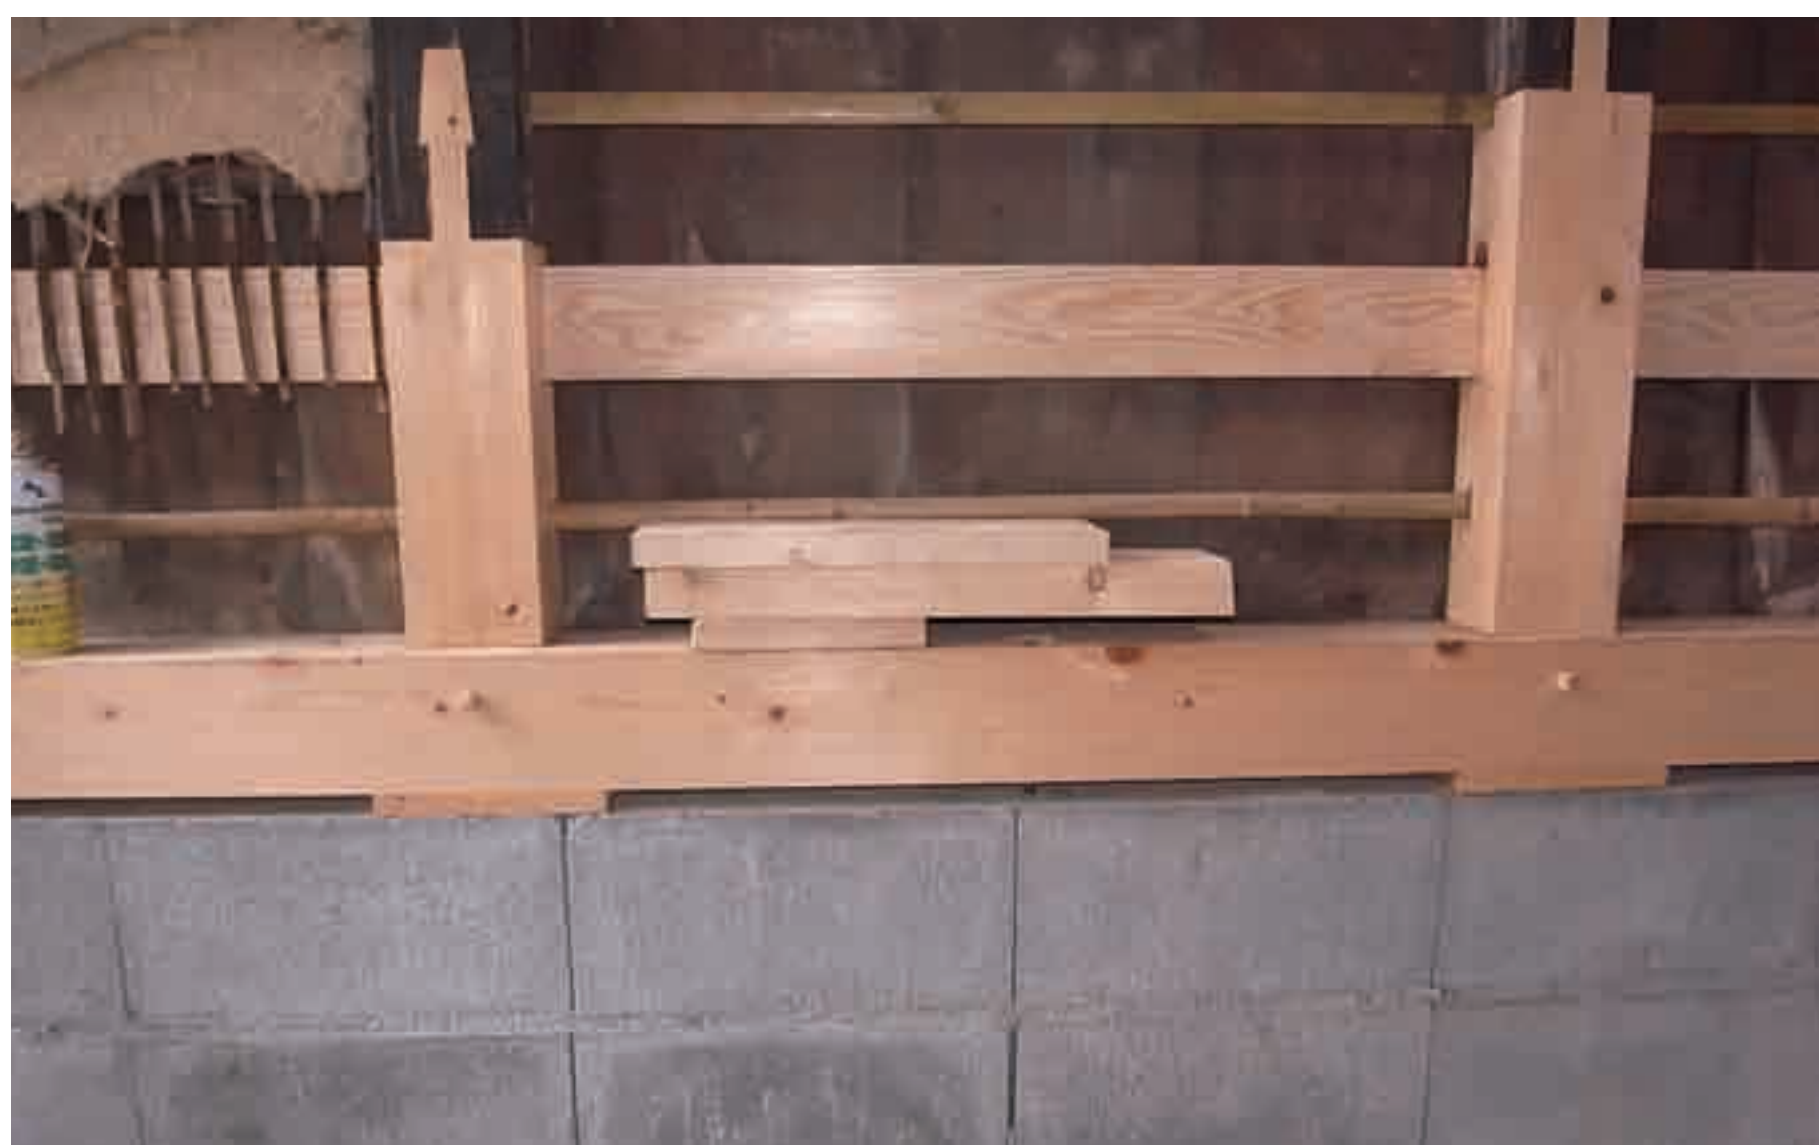
コンクリートブロックの高基礎上に東側柱列を土台と通し貫を新しく入れて載せ直す
putting on retrofitted post & beam on new CB foundation
