釜座町町家の由来と町家修復のポイント

History of Kamanza Cho-ie and its Restoration

Kyoto Machiya Revitalization Project

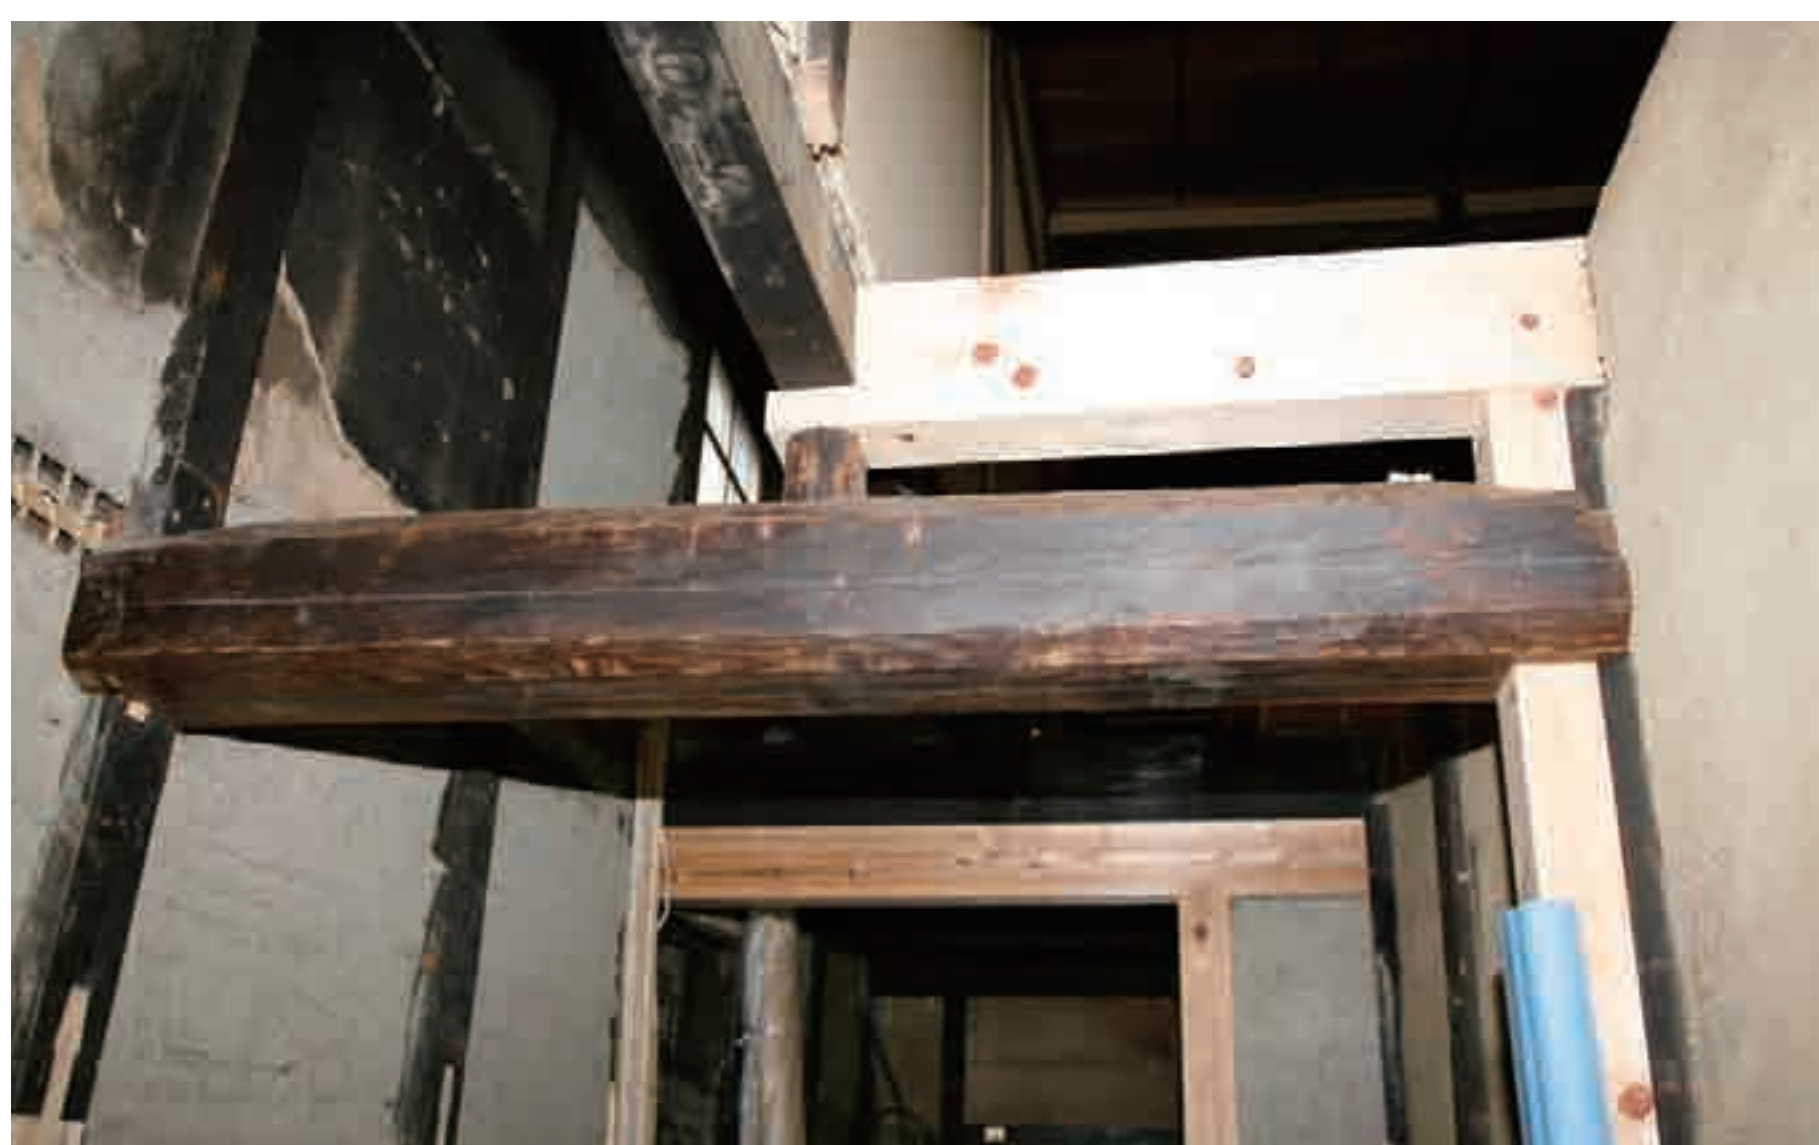
火袋の架構を修理補強 梁と添え柱を入れる
retrofitted post & beam

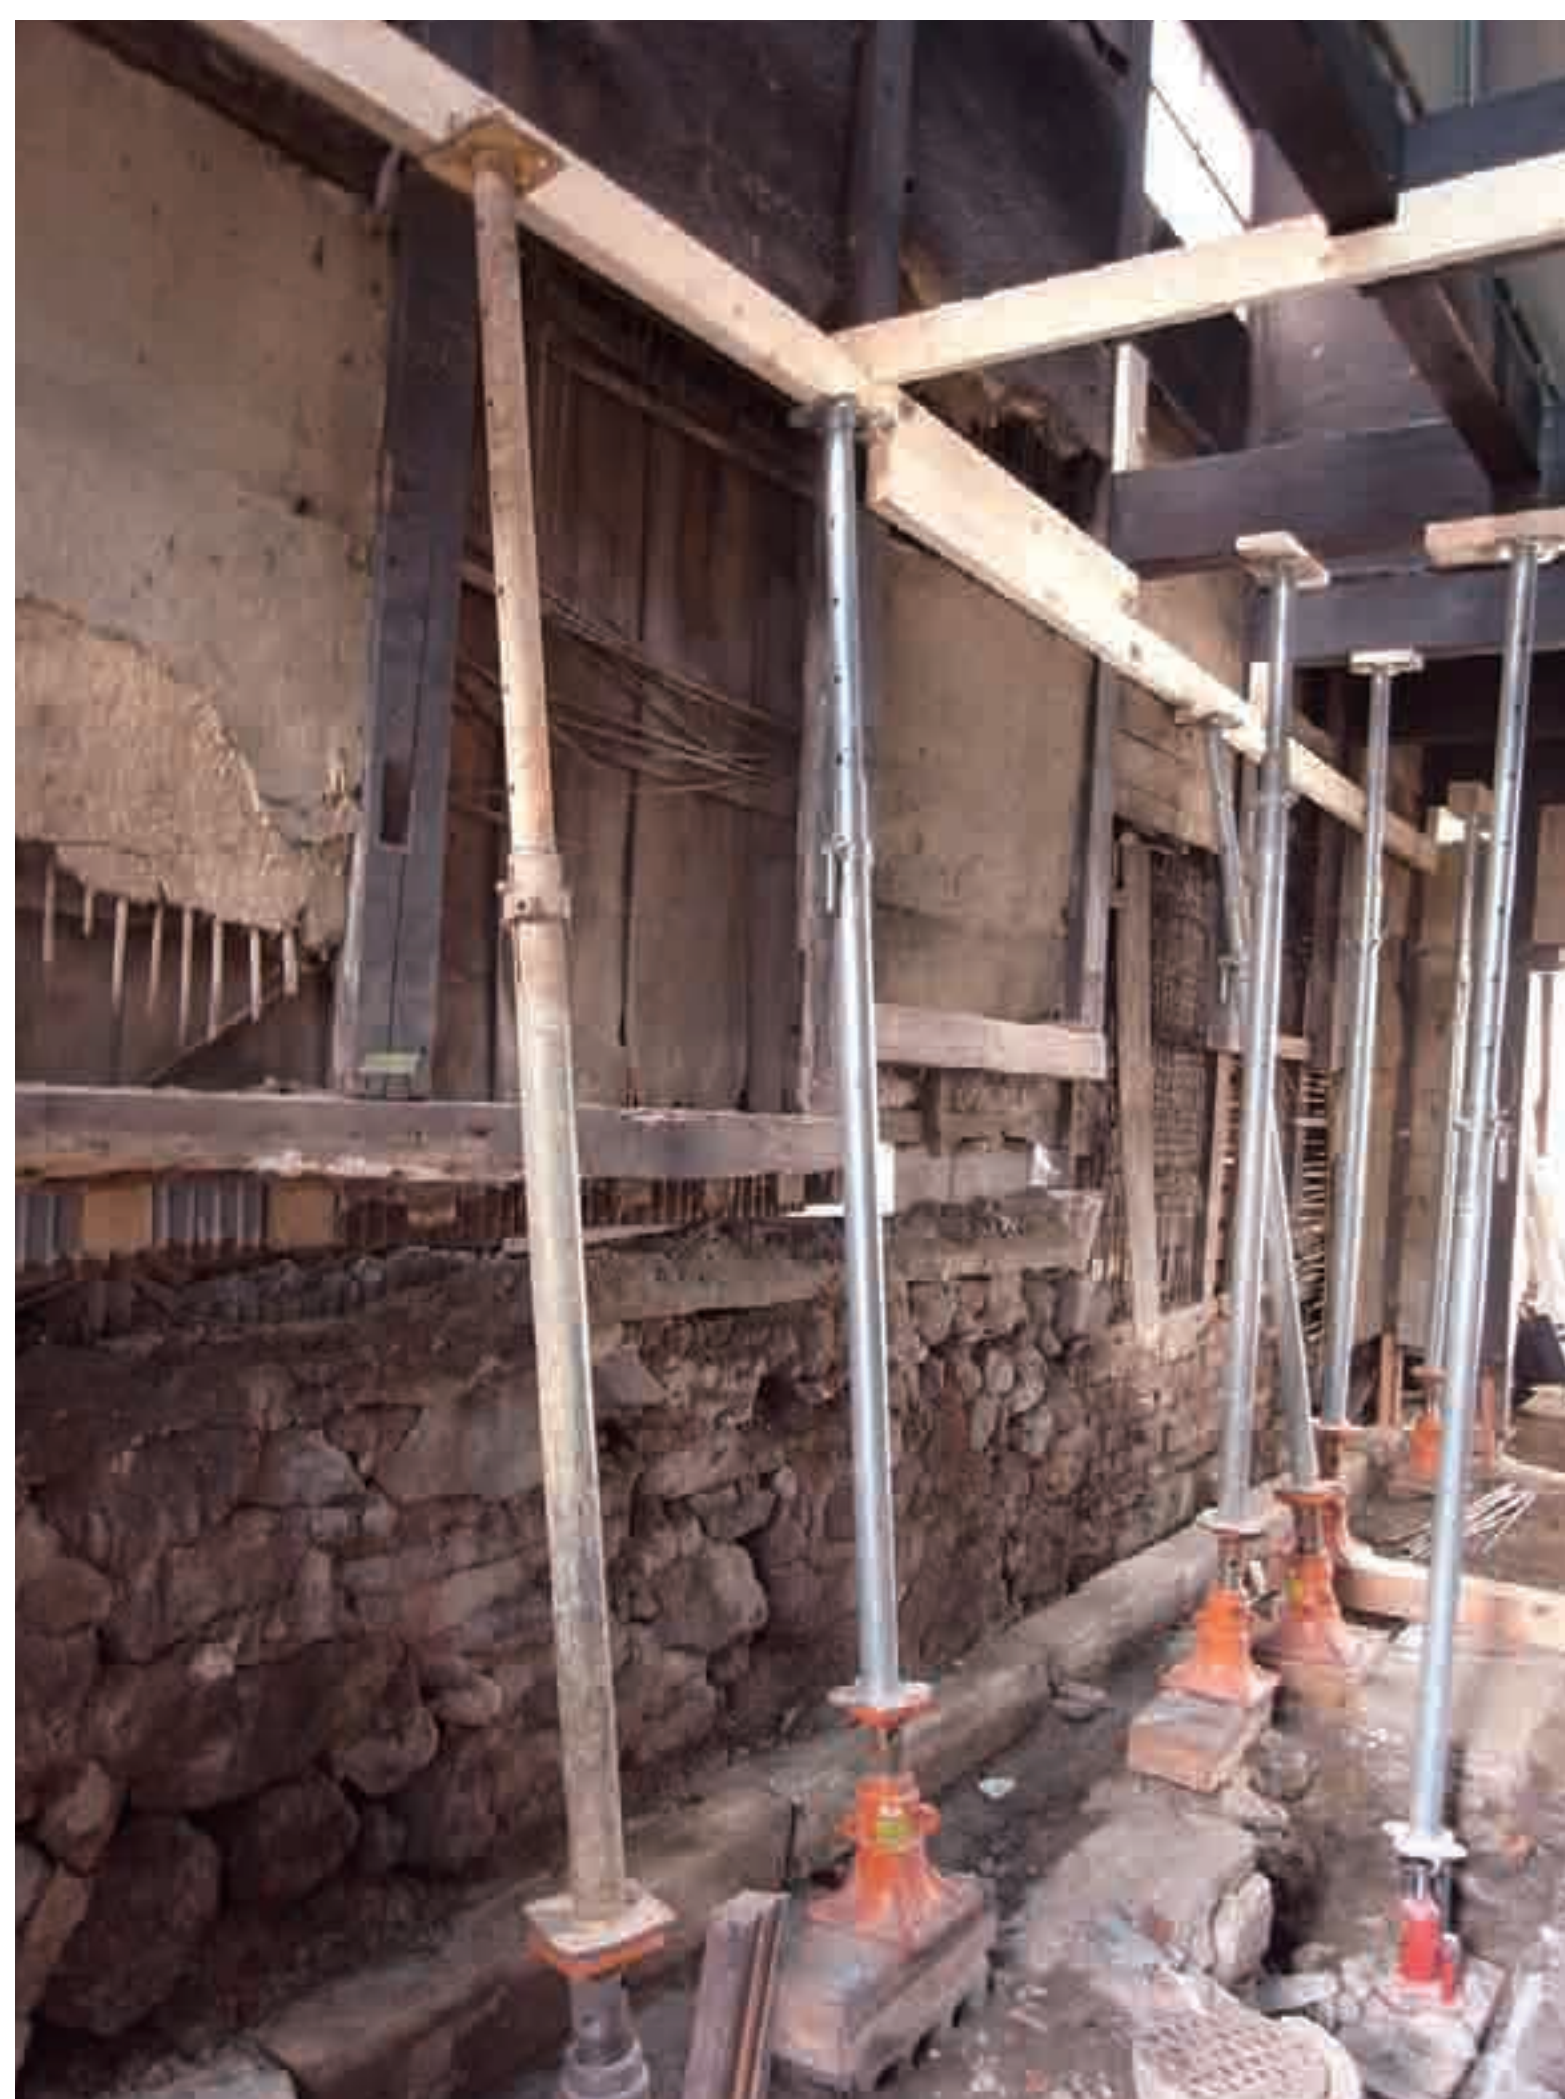
側壁歪み突き retrofitting side wall

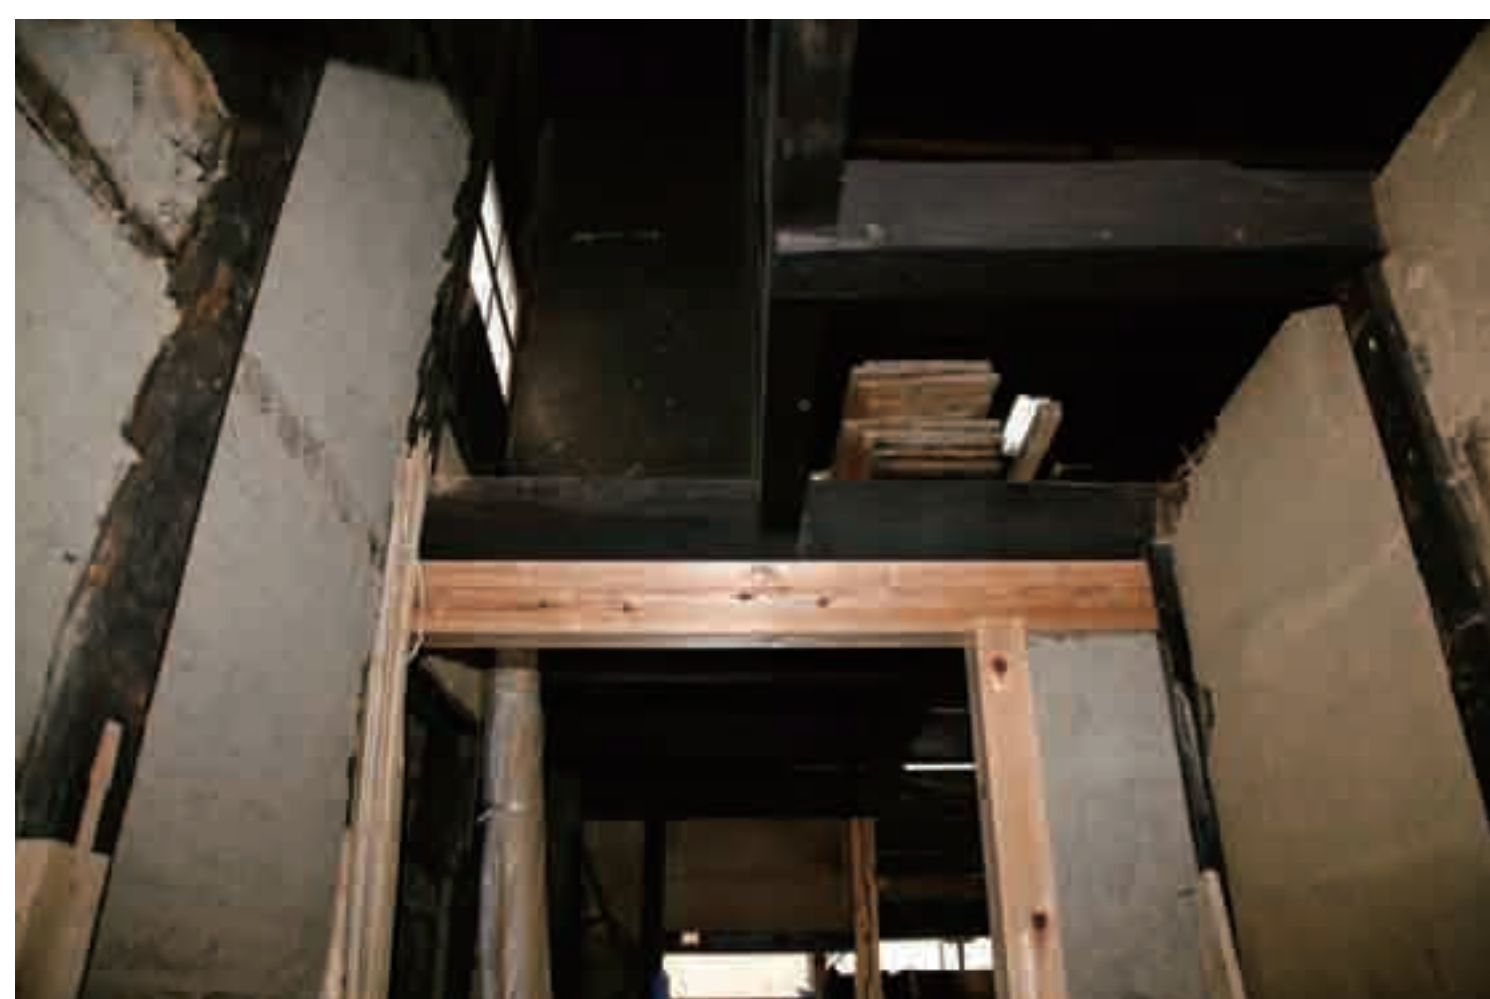
胴差の補強と管柱の差し換え
adding support beam & post

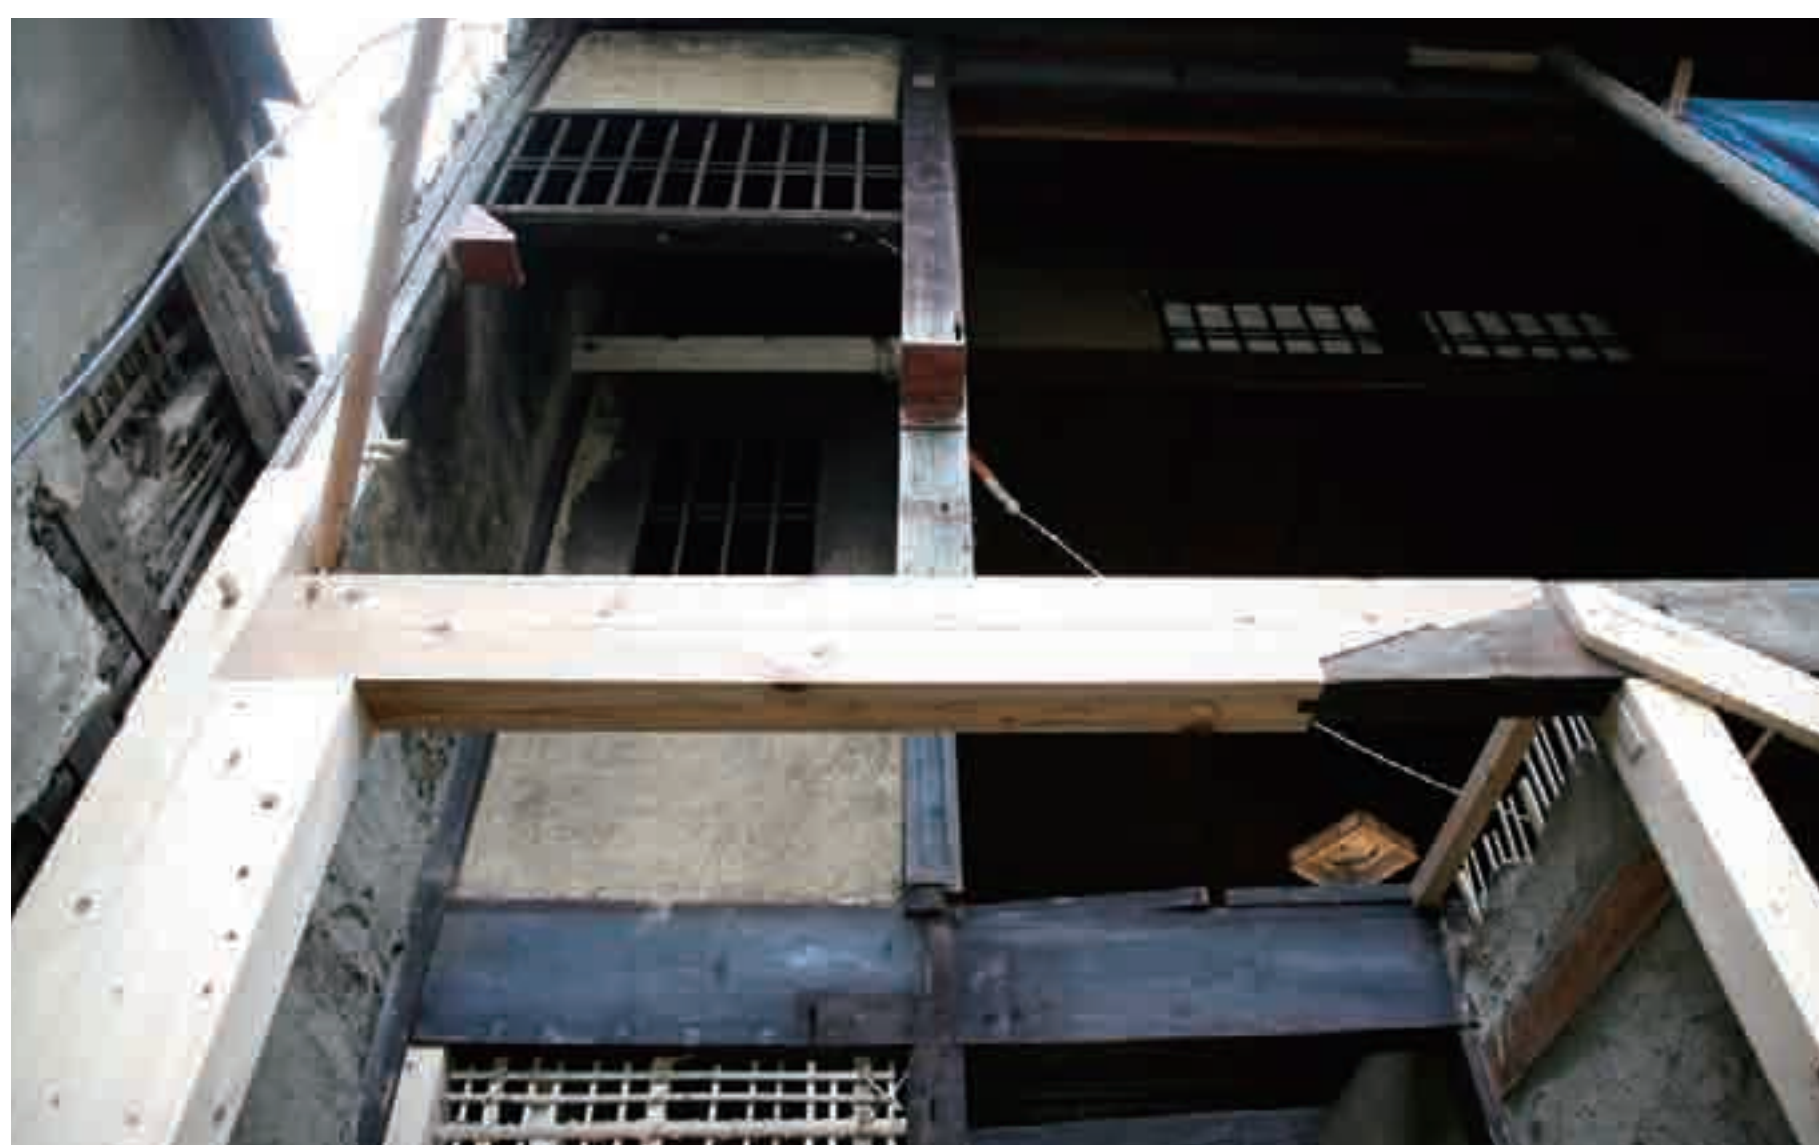
縁側の胴差の腐朽箇所を取り換える
repaired beam & support post

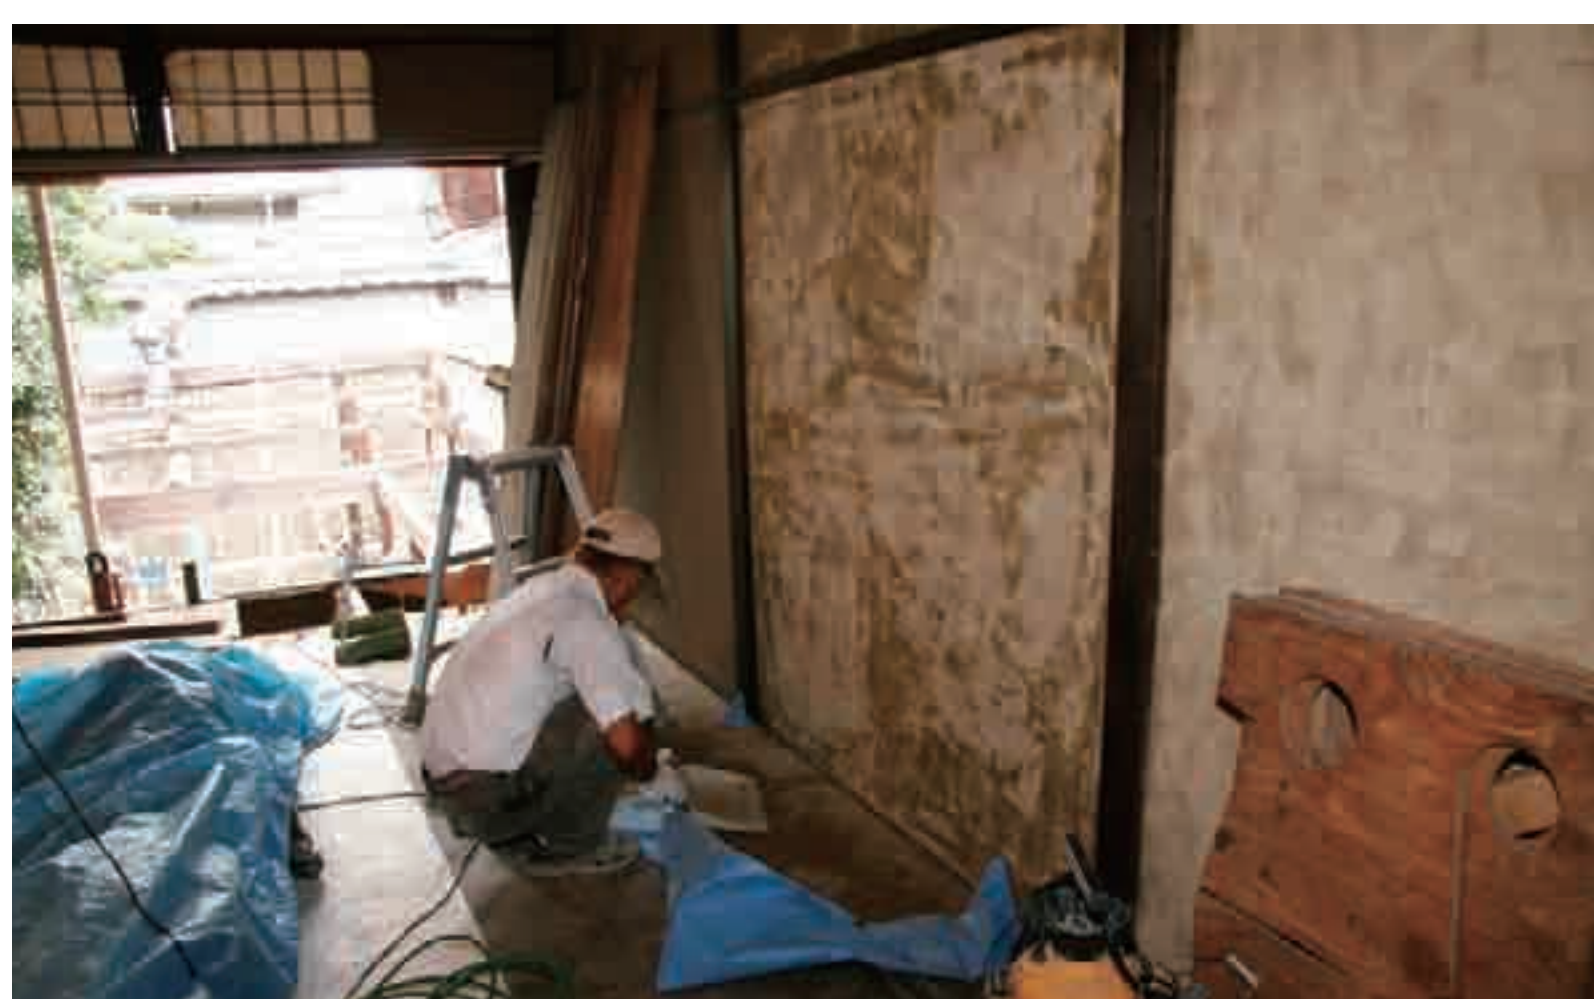
既存土壁仕上層を剥す taking off top coat of clay wall

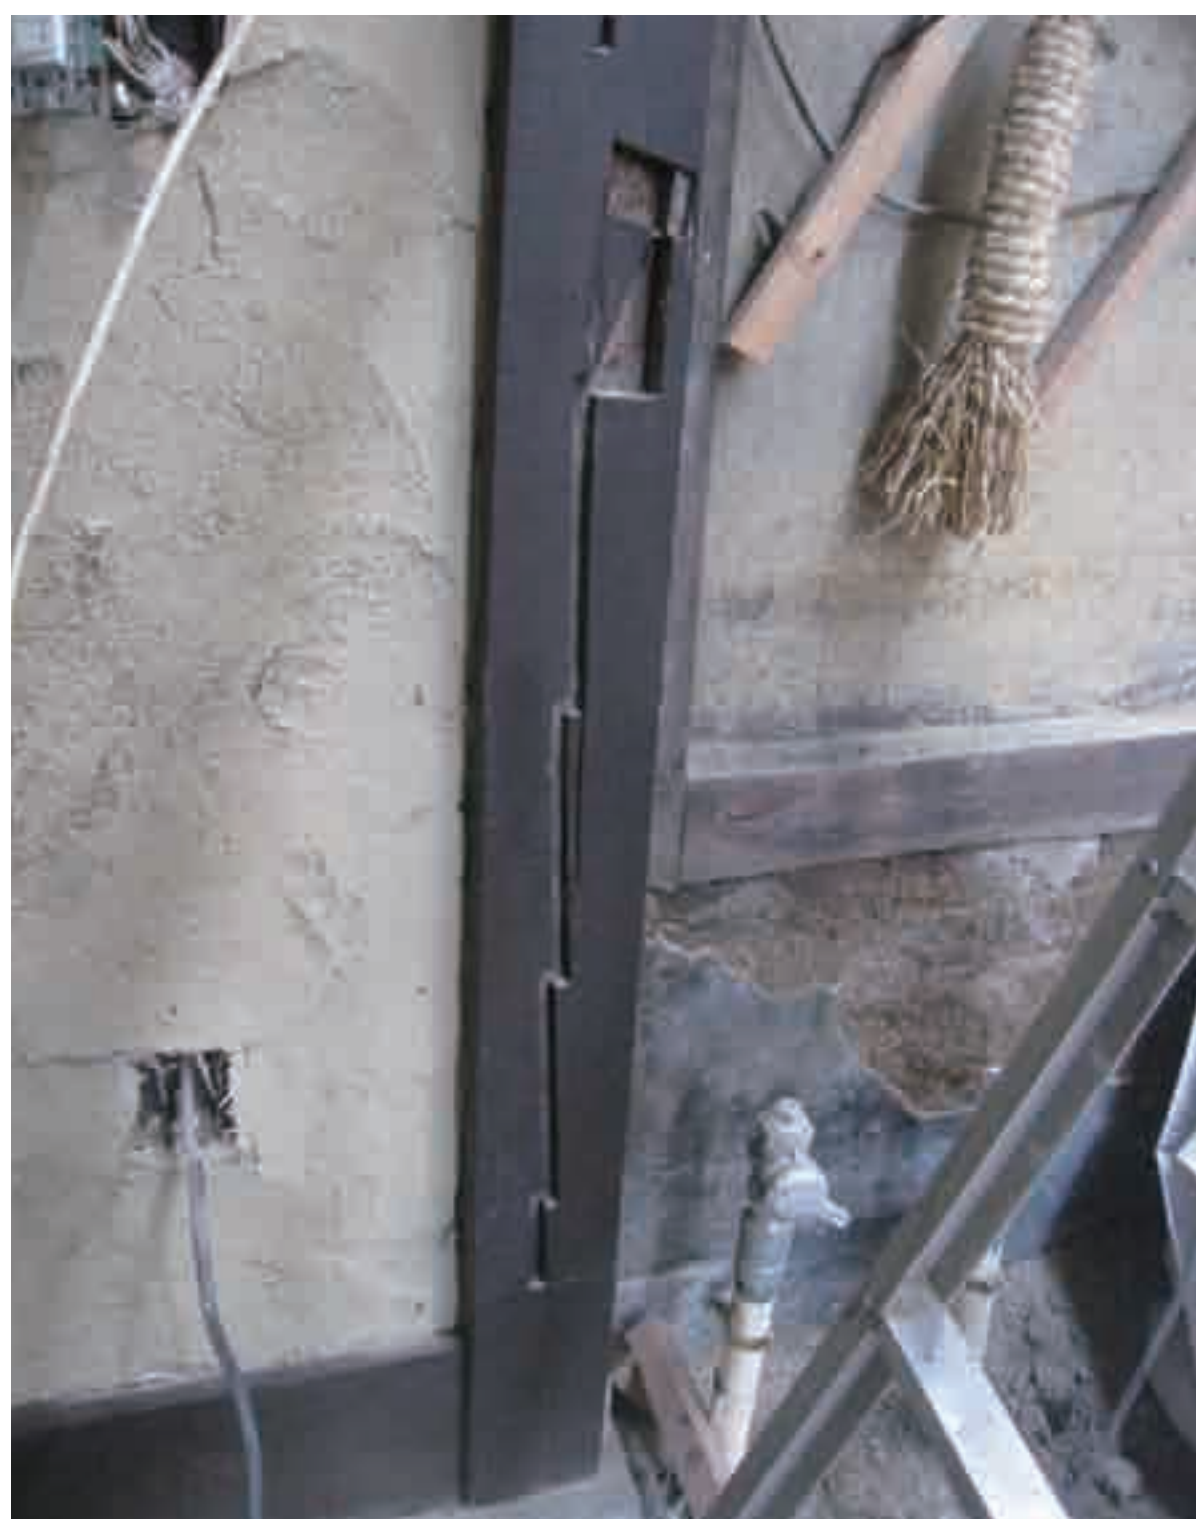
玄関袖壁の鎧張り痕跡
vestigial mortise of dado

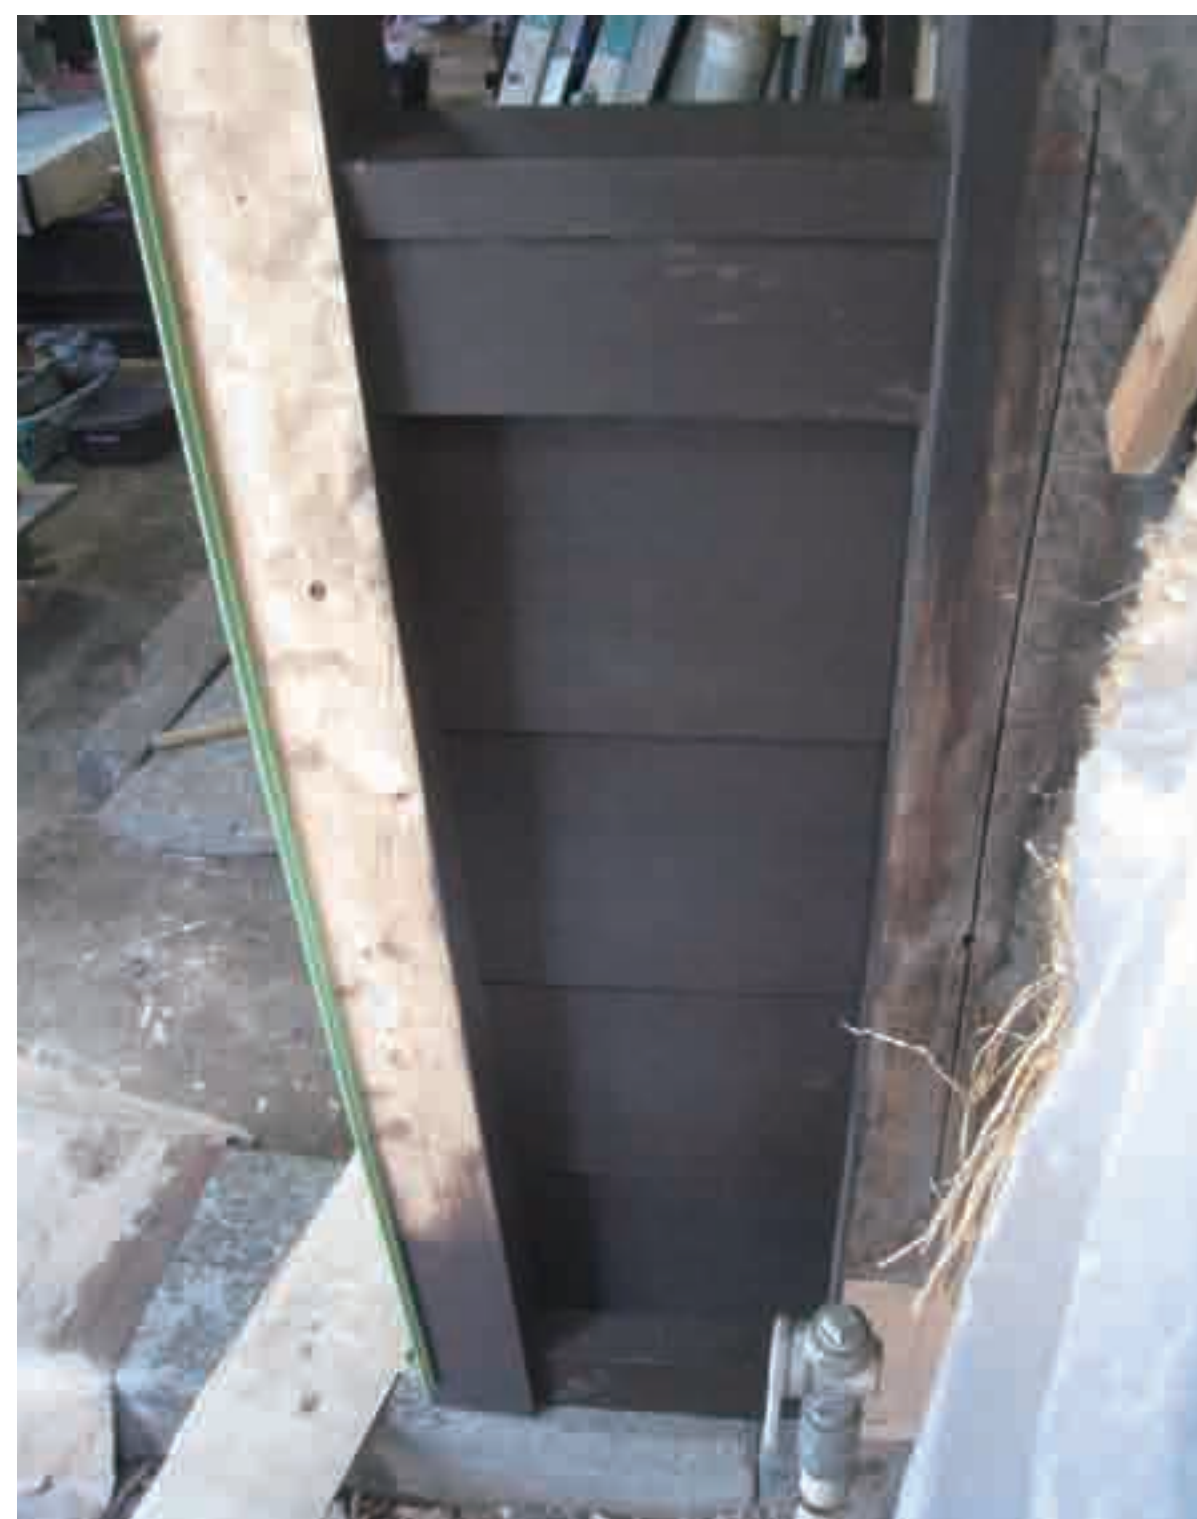
復元
restored dado

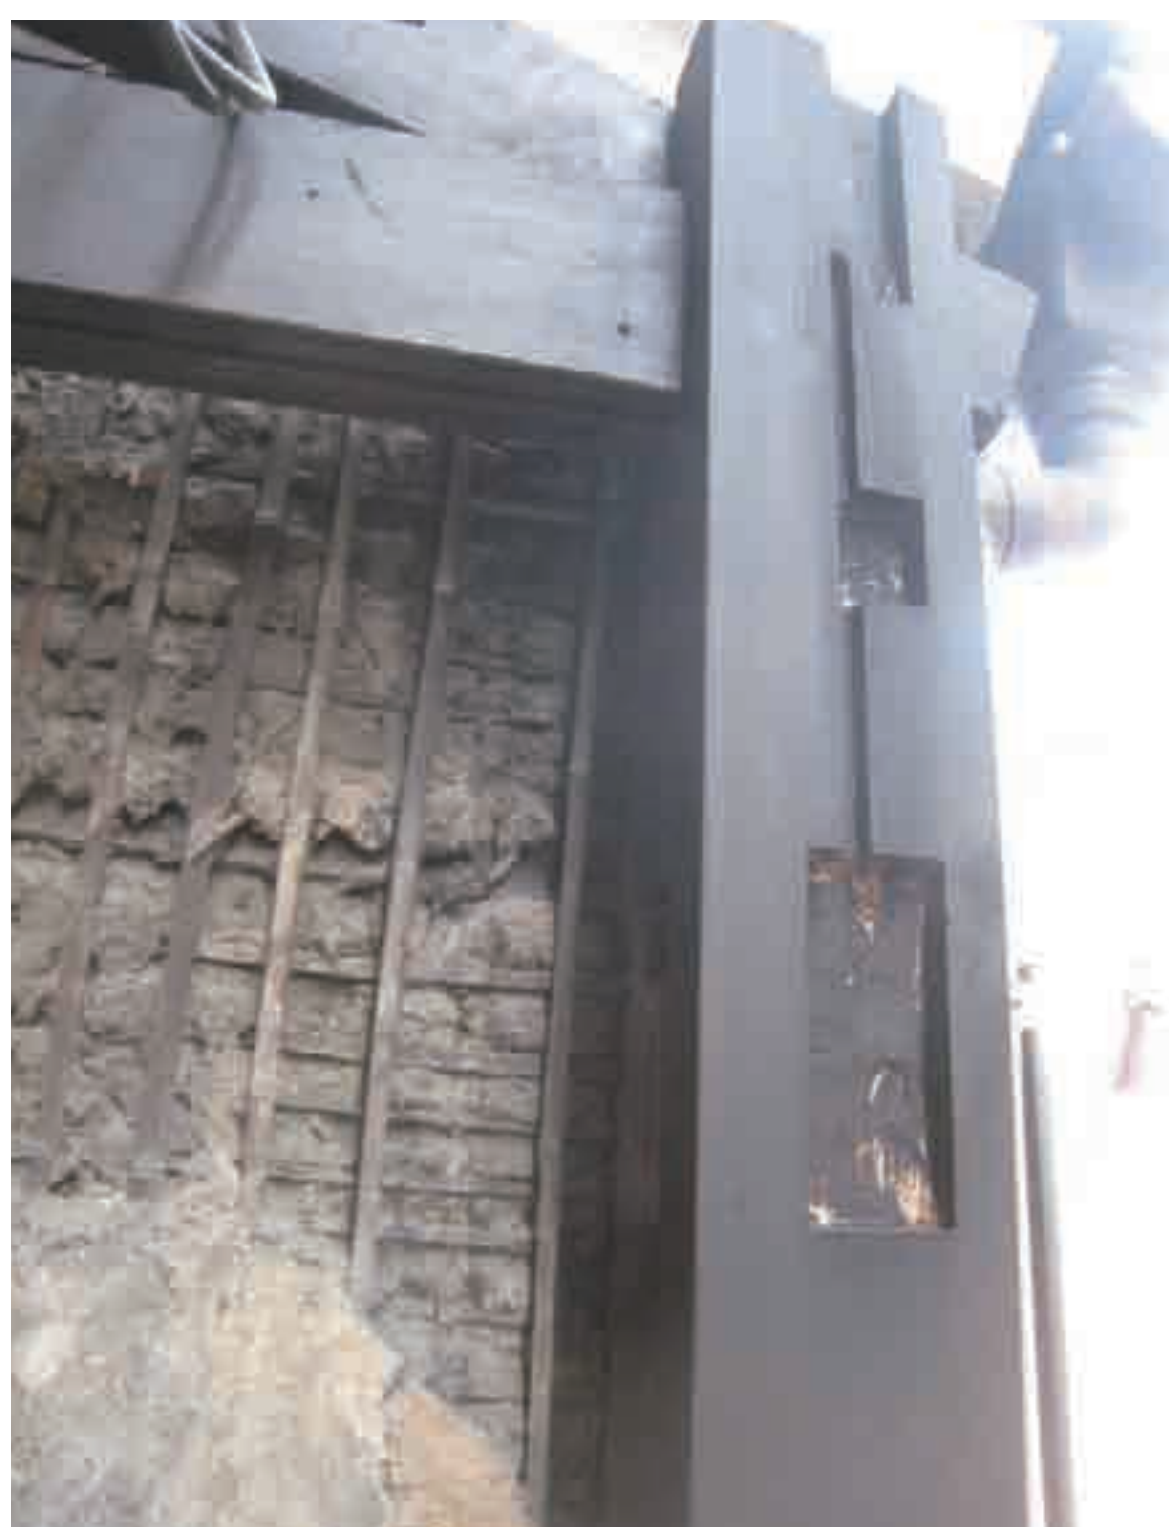
幕掛の痕跡
vestigial mortise of makukake

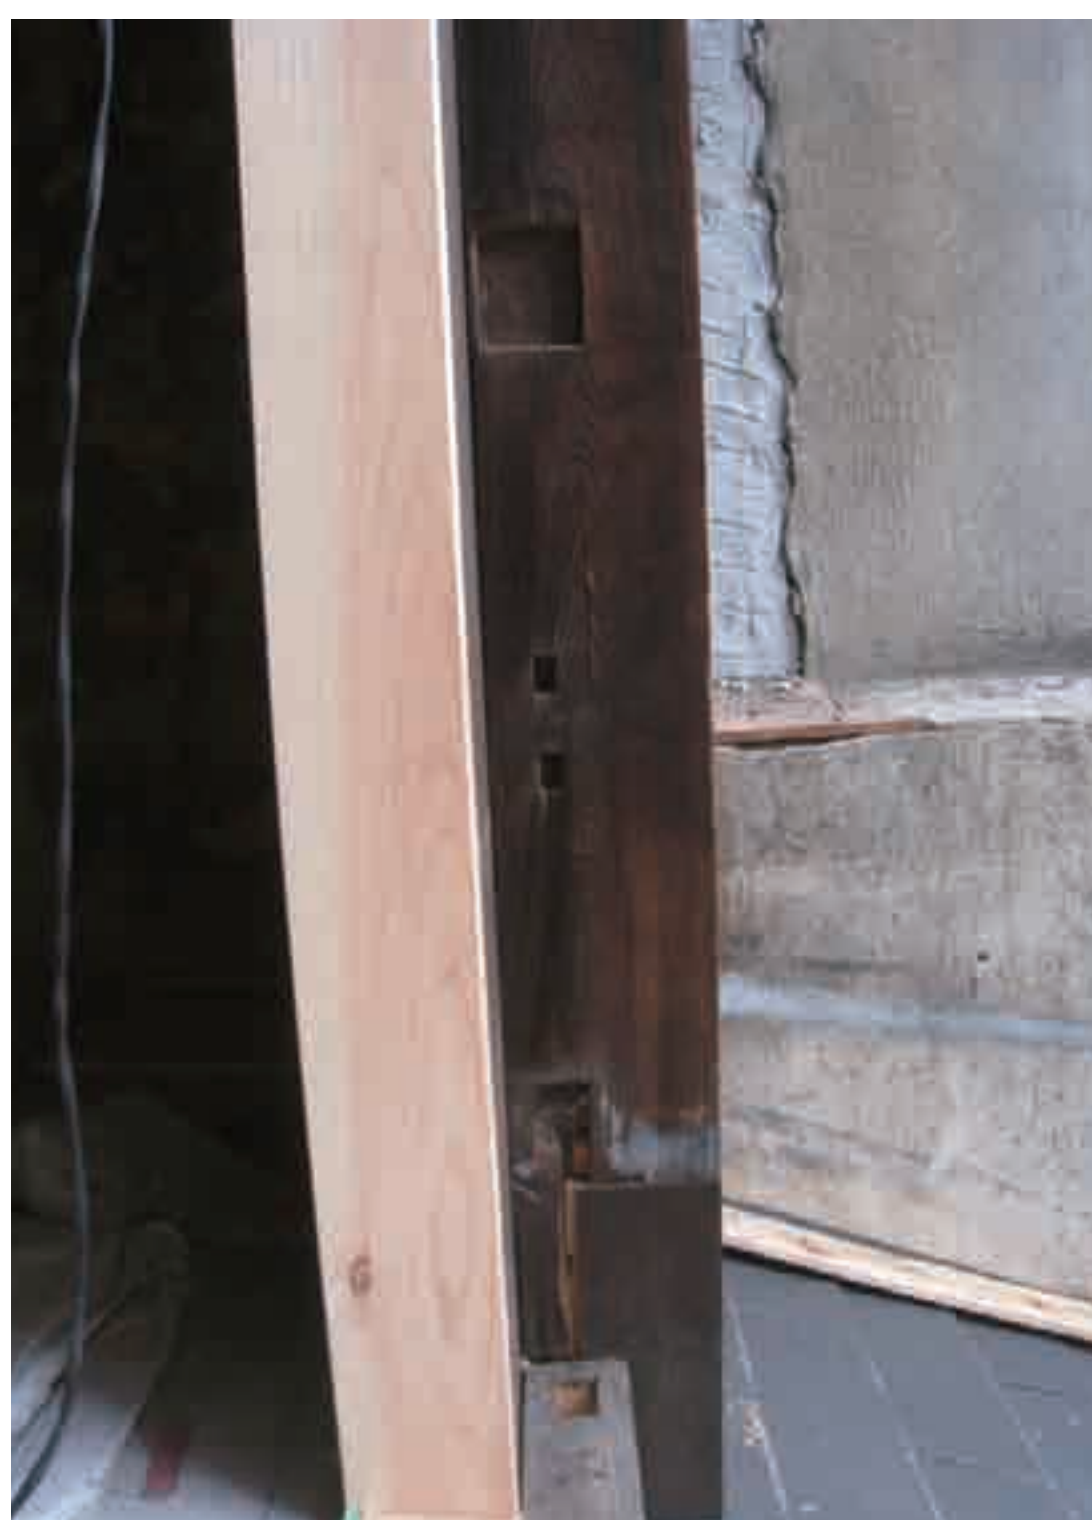
欄干の痕跡
vestigial mortise of exterior railing

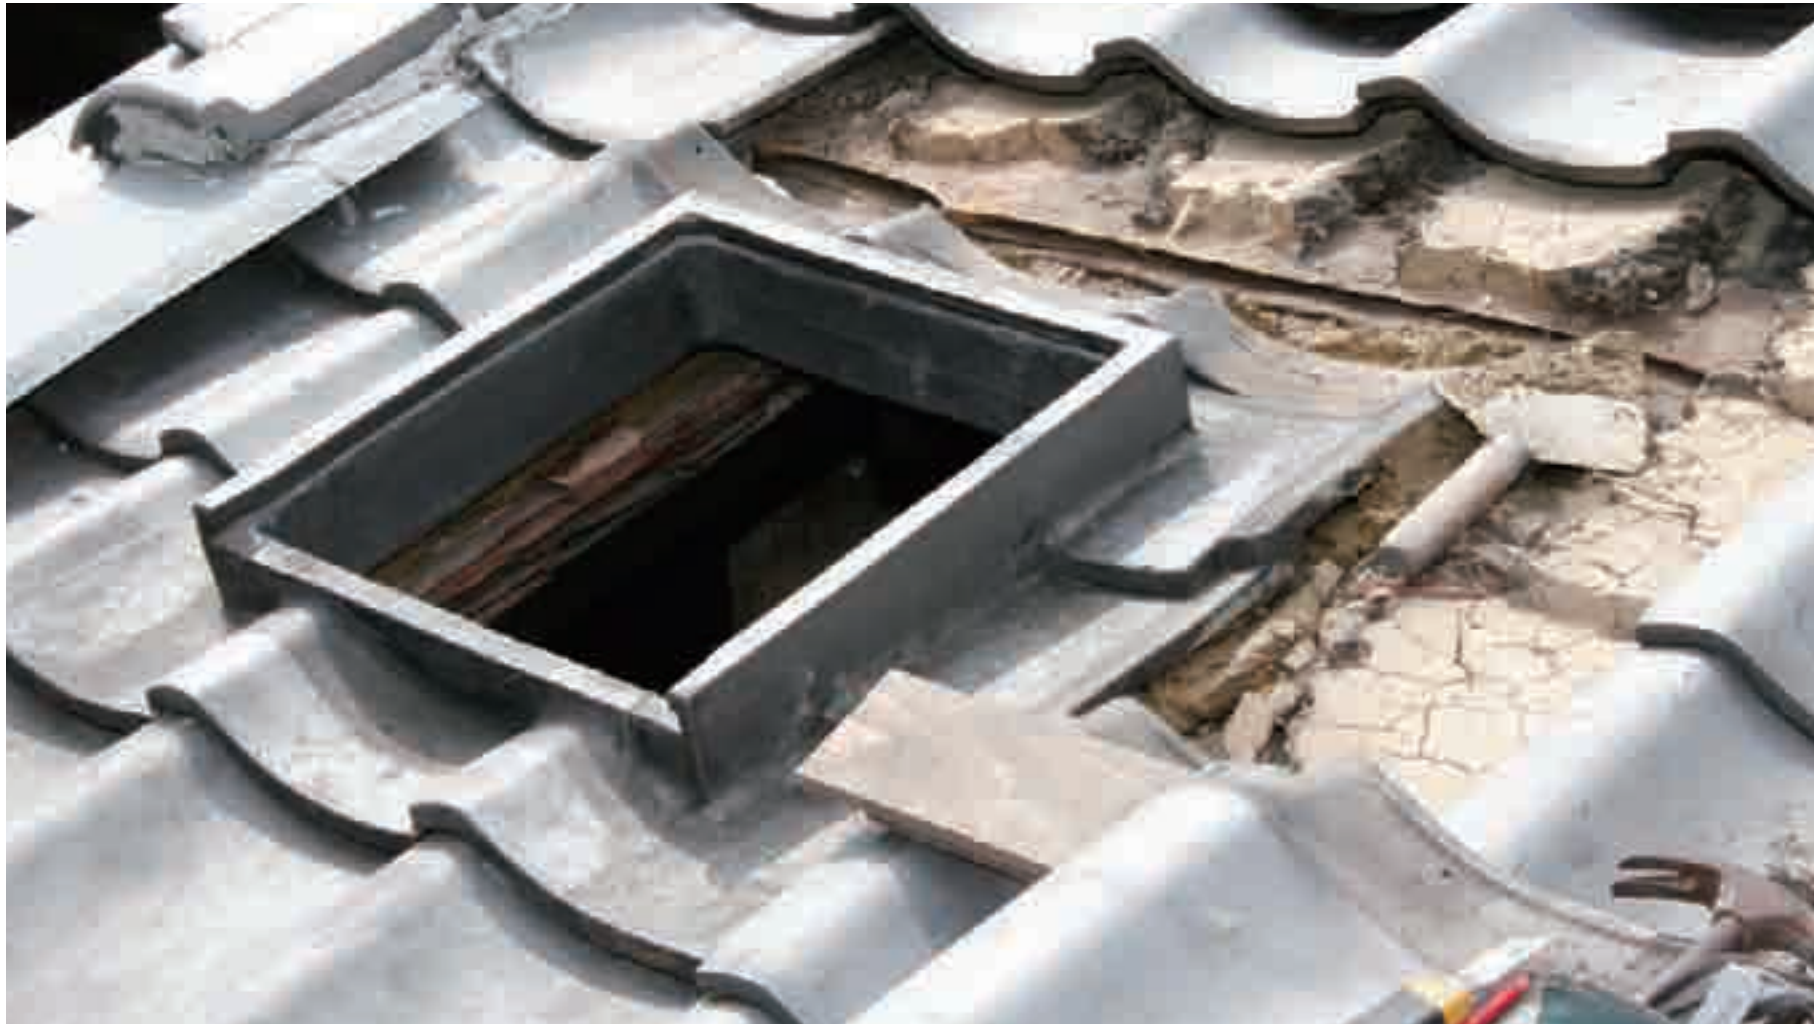
トップライト top light of tile roofing

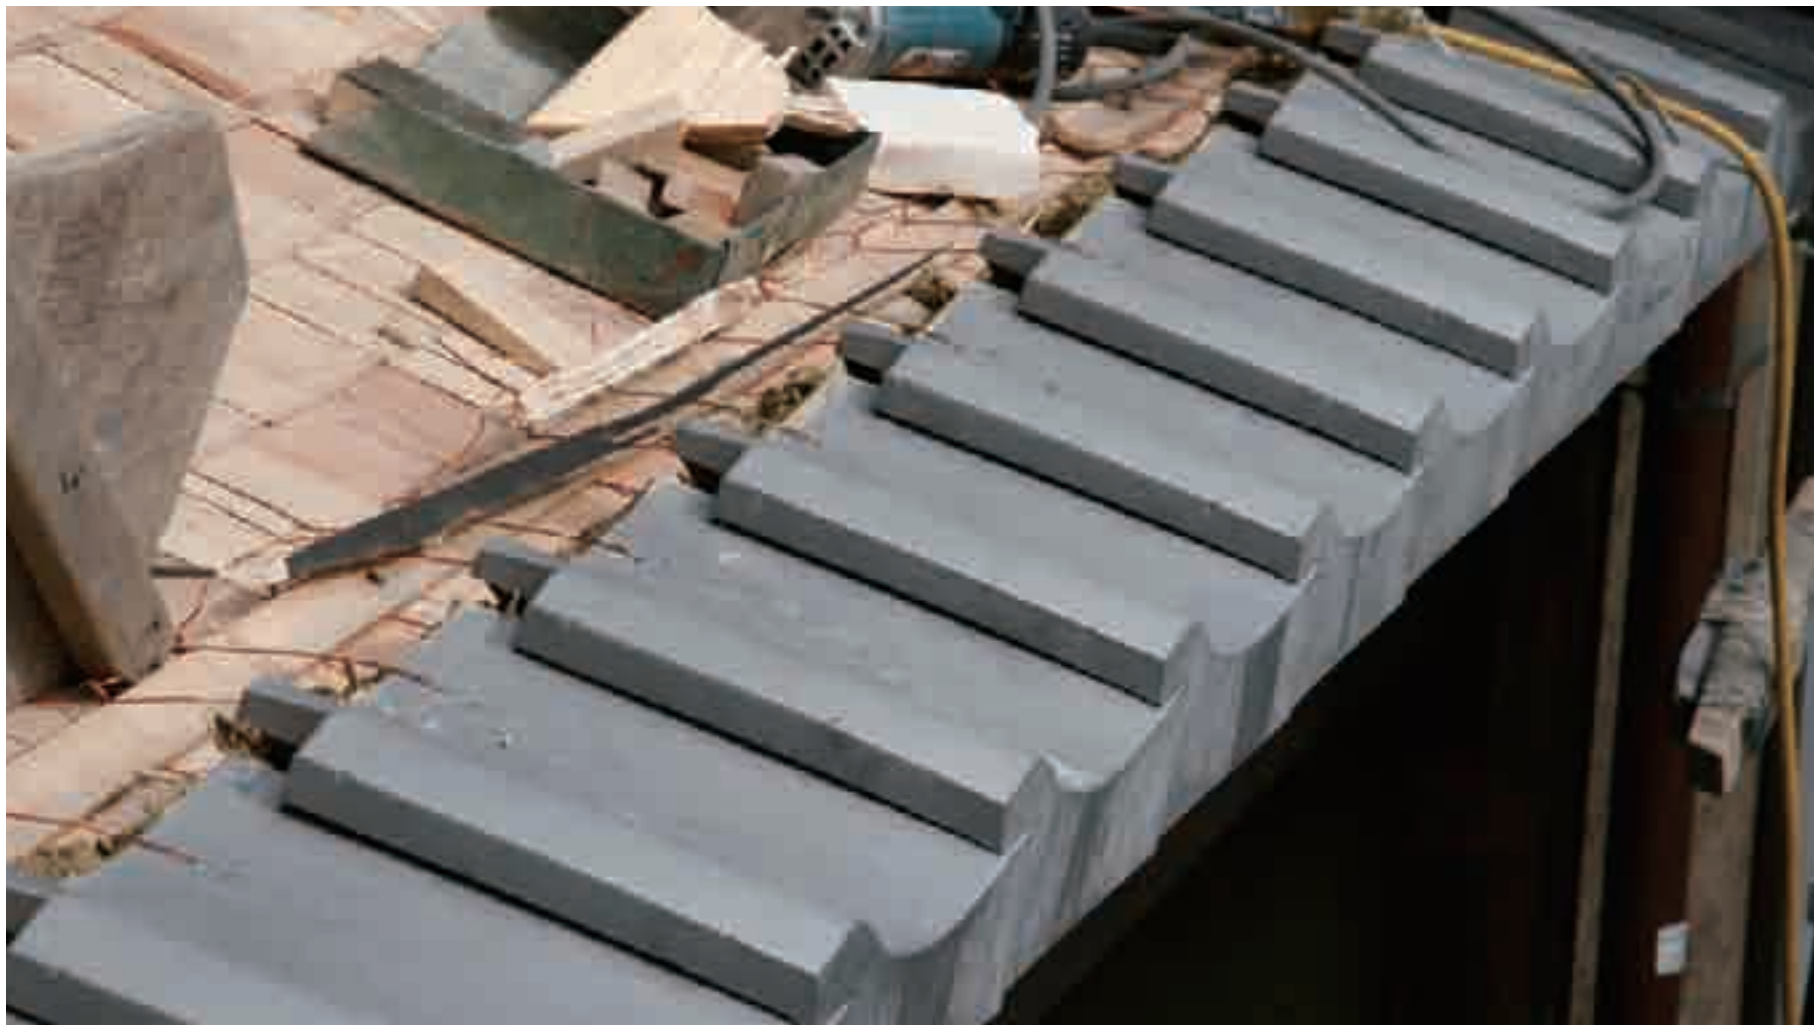
一文字軒先を揃える eaves tiling

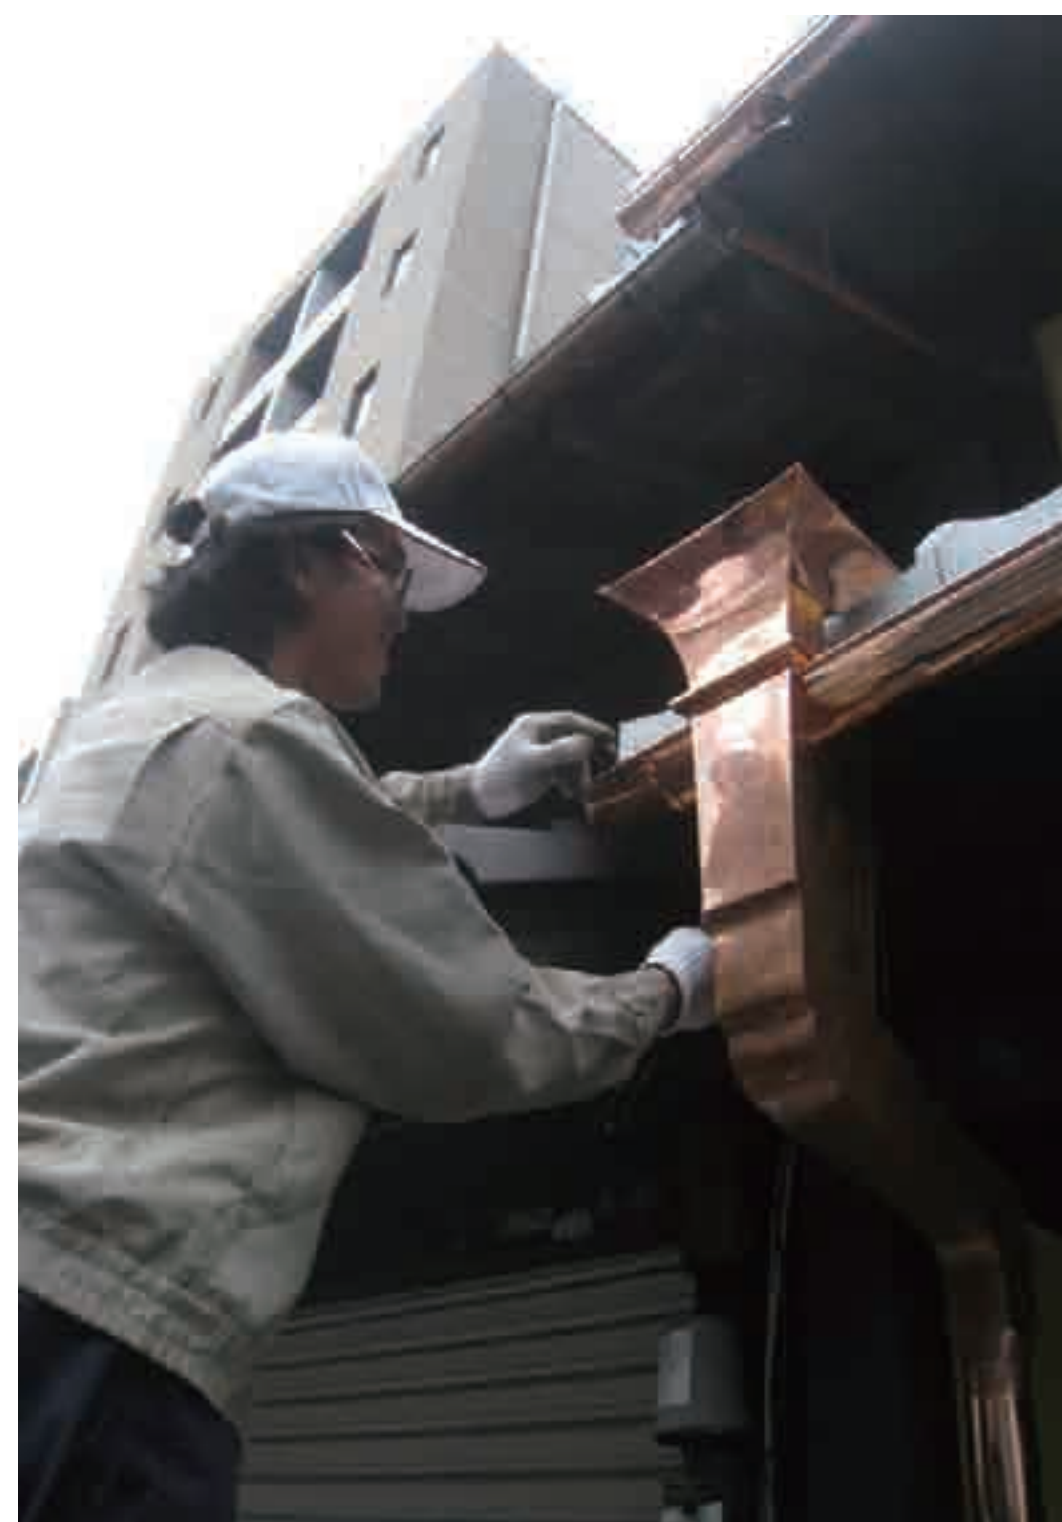
京アンコウの取り付け
kyoto-style drain spout
